F-JC Stream Reach Summary

Study Reach: F-JC, Jim Creek - Denver Water diversion downstream to Fraser River.

GRAND COUNTY
STREAM MANAGEMENT PLAN
REACHES

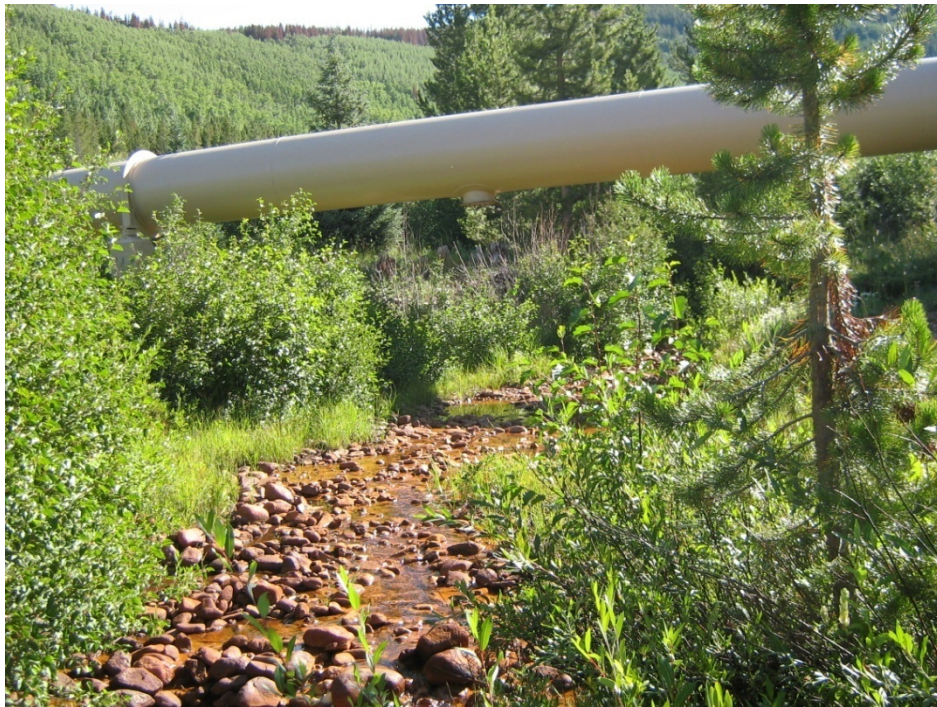
Jim Creek is a small mountainous stream that's tributary to the Fraser River near the Winter Park Ski area. Approximately one mile upstream from its confluence with the Fraser River Jim Creek is captured almost in its entirety and diverted to the Moffat collection system. Upper sections of Jim Creek below the diversion are typically dry, or damp, while lower sections are wetter with a trickle of flow at some times. In late August 2008 the flows were measured at less than 0.1 cfs in this lower section. Rock staining is extensive.

Jim Creek at the Fraser River canal pipeline
