F10 Stream Reach Summary

Study Reach: F10, Fraser River – Town of Granby at U.S. Highway 40 downstream to Colorado River confluence at Windy Gap.

GRAND COUNTY
STREAM MANAGEMENT PLAN
REACHES

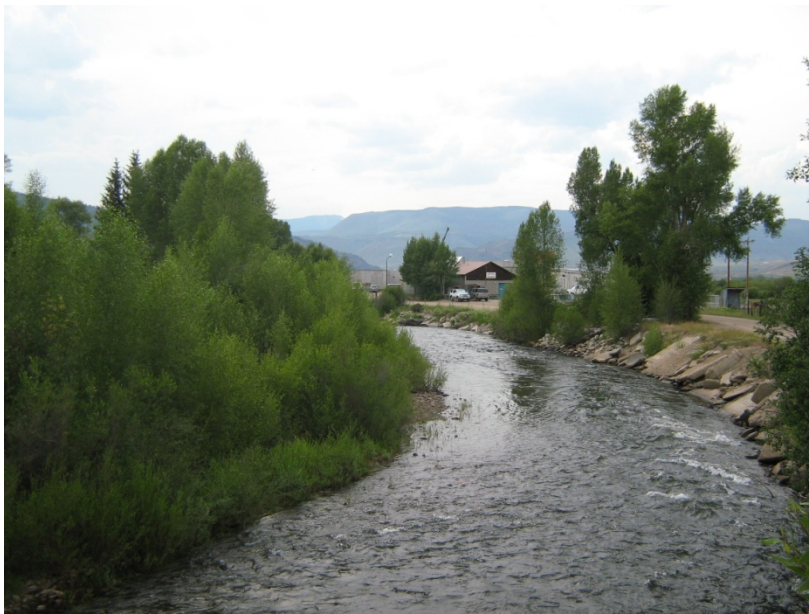
Fraser River at County Road 57 near Town of Granby

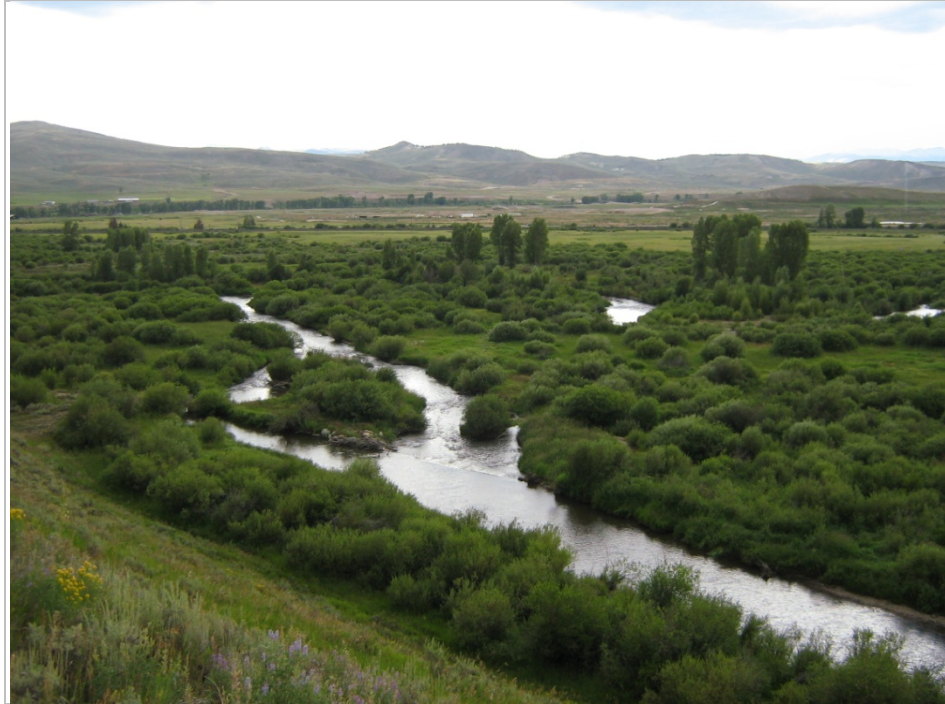
Fraser River at Upstream of Windy Gap

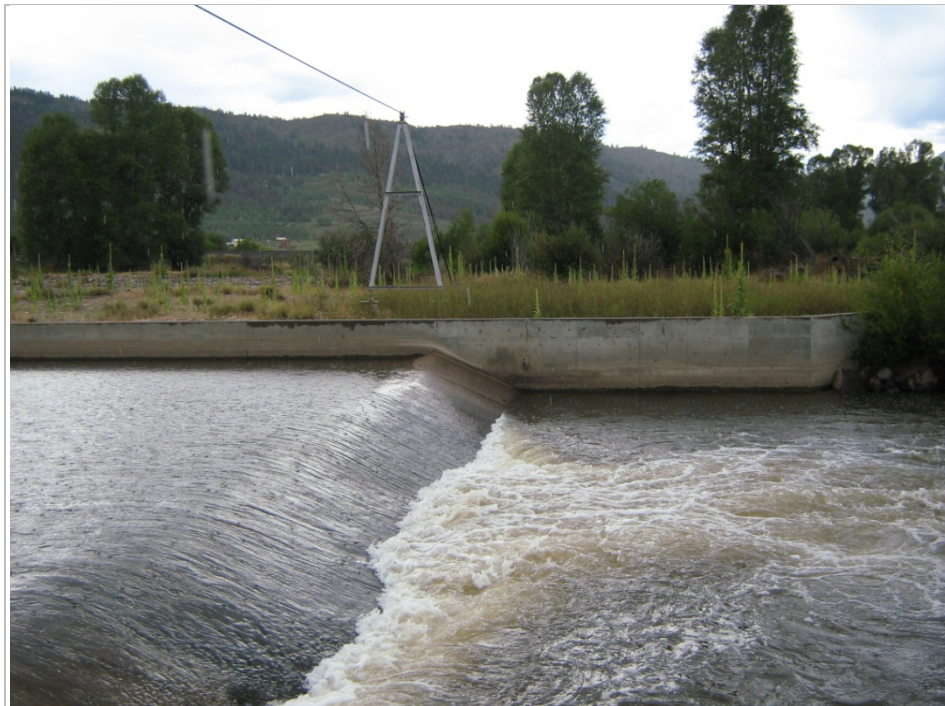
This portion of Fraser remains relatively sinuous and, in areas, appears braided. Fraser River confluences with Ten Mile Creek in the upstream portion of this reach and the Colorado River (CR3) at the downstream terminus of F10 just before entering Windy Gap. The overbanks are typically covered with wetland-type vegetation. Some development is evident, especially near Granby on the upstream end of this reach. A restoration project was completed for a portion of this reach within or near the Town of Granby. Details and site specific improvements were not available for inclusion in this Reach Summary. Downstream, the adjacent development is set further away from the river leaving the floodplain and wetland vegetation relatively undisturbed. Just upstream of Windy Gap the river is re-confined to a constructed channel, passing under the railroad and through a concrete lined gaging station immediately upstream of the Colorado River confluence.

Gaging Station upstream of the Colorado River confluence

5. The fish passage barriers in this reach include the Granby Diversion and the NCWCD gage site. These structures present impediments to upstream fish migration.

- ✓ Investigate opportunities for improving fish passage at the Granby Diversion and the NCWCD gage site

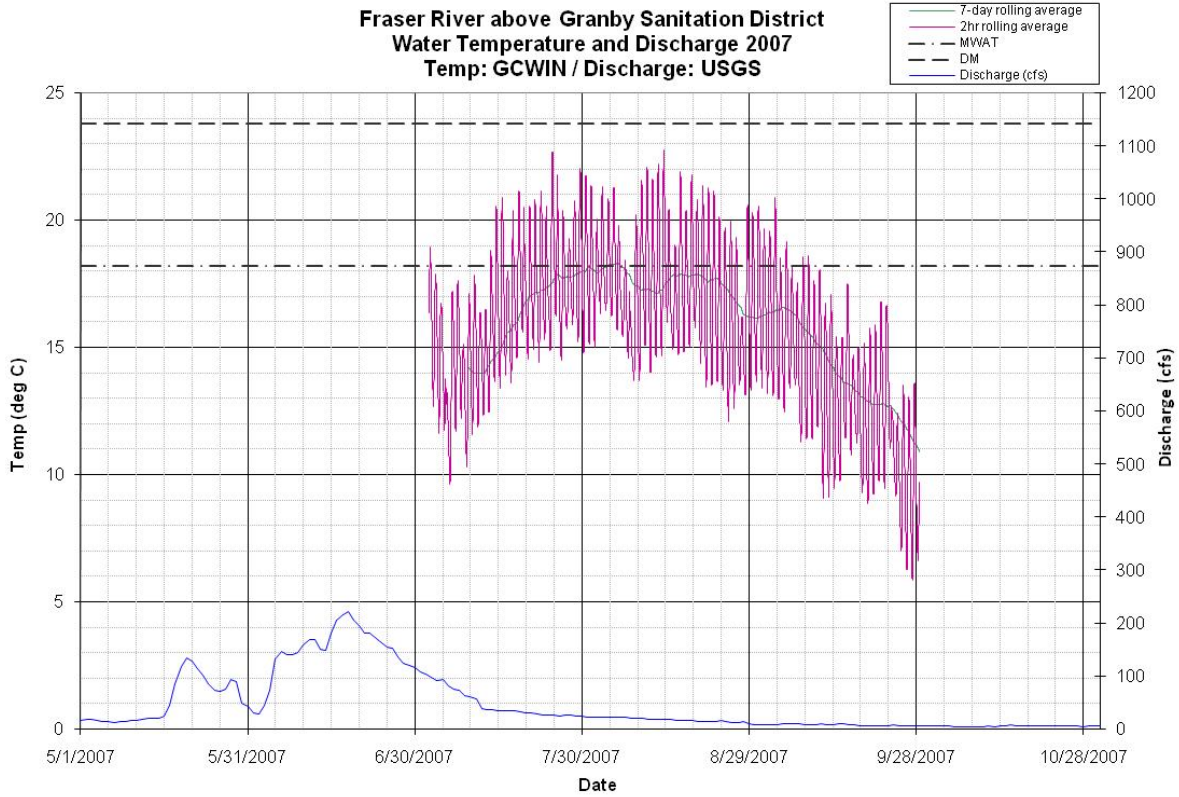
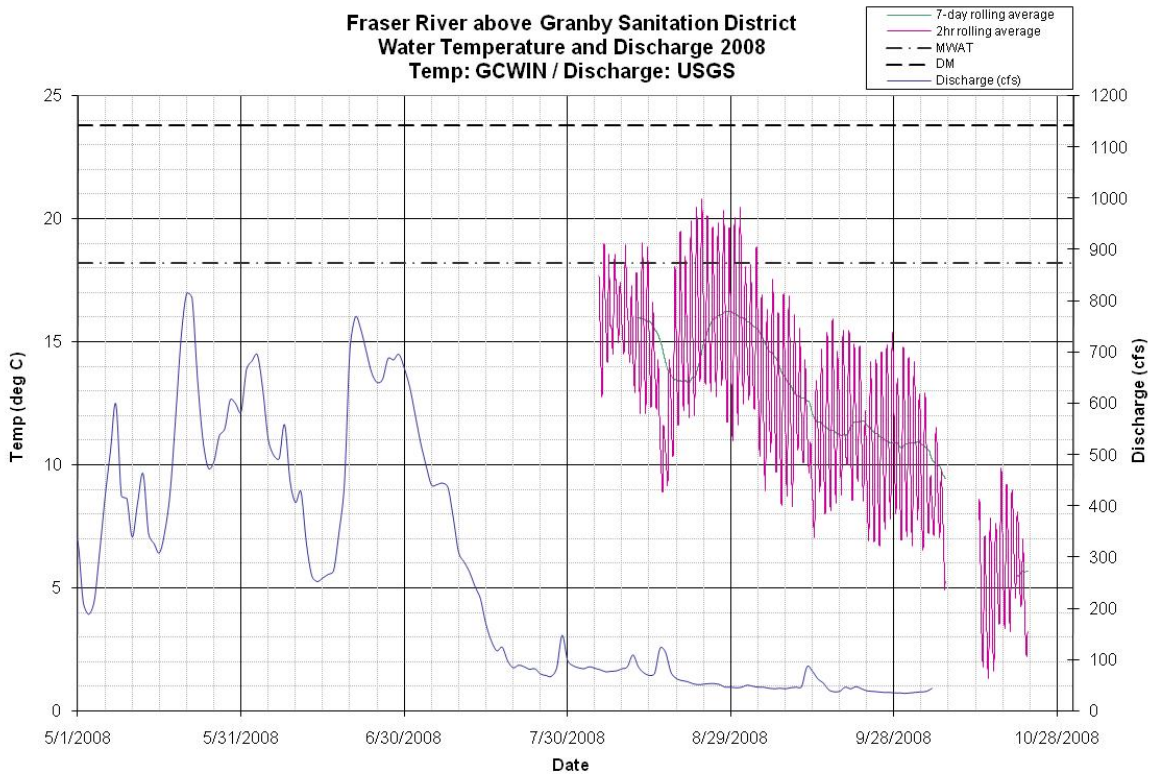
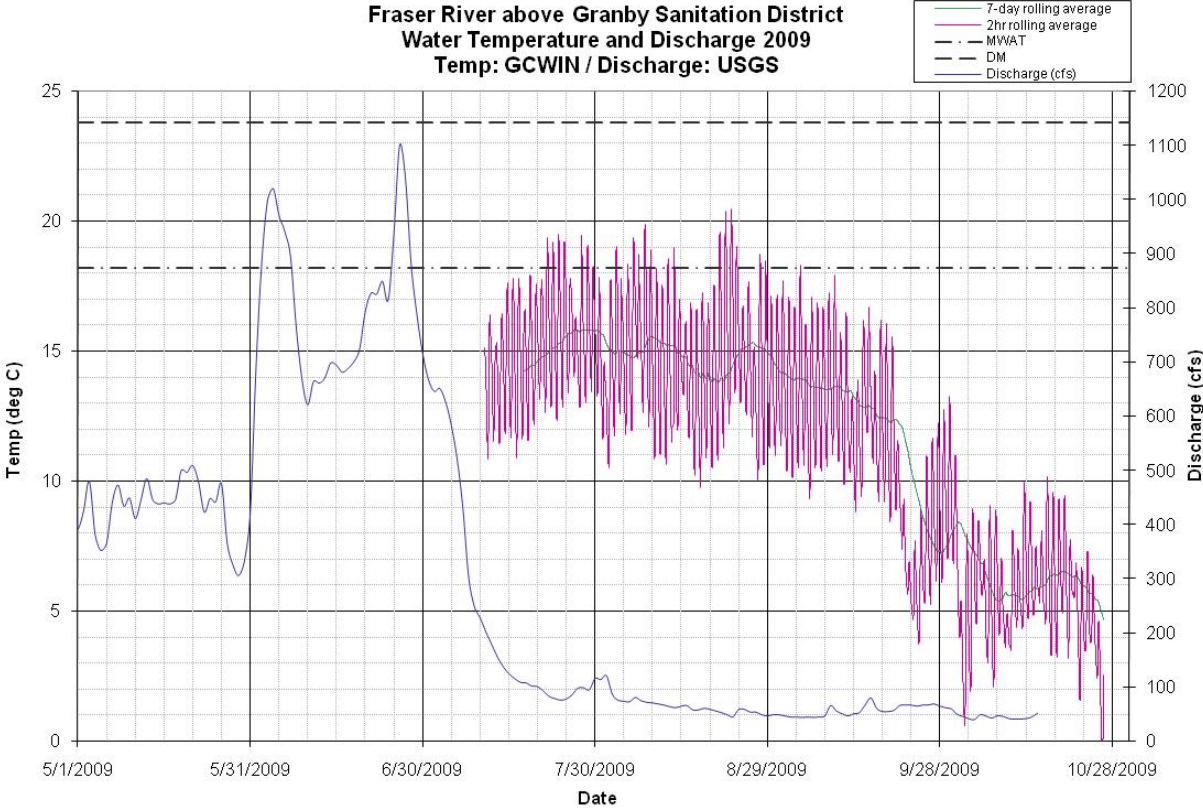
Surface Water Temperature Plots

Water Temperature: F10 is a Tier II stream reach as designated by CDPHE with a chronic temperature standard of 18.2°C MWAT and an acute temperature standard of 23.8°C DM. Temperature data reviewed in reach F10 indicate stream temperatures for the Fraser River in this area are generally below the MWAT and DM standards. However, some exceedences have occurred and resulted in placement of F10 on the 303 (d) list of impaired waters for temperature, with a low priority.
