F7 Stream Reach Summary

Study Reach: F7, Fraser River - Ranch Creek confluence downstream to Canyon below Strawberry Road.

Reach Description: Approximate channel length: 1 ½ miles, approximate channel slope 0.6%.

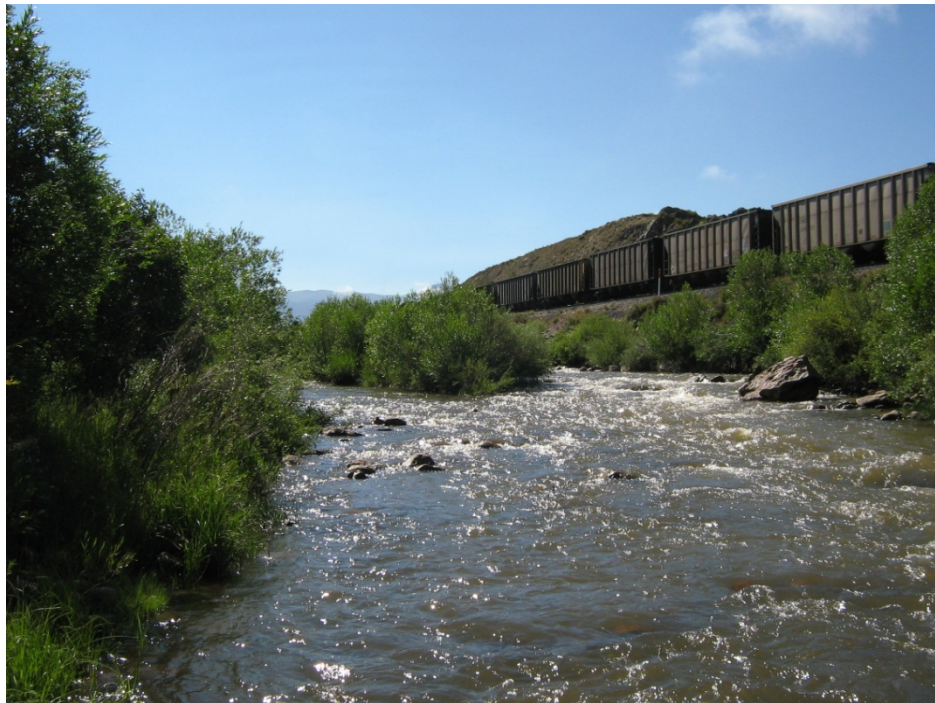
Fraser River below Ranch Creek Confluence

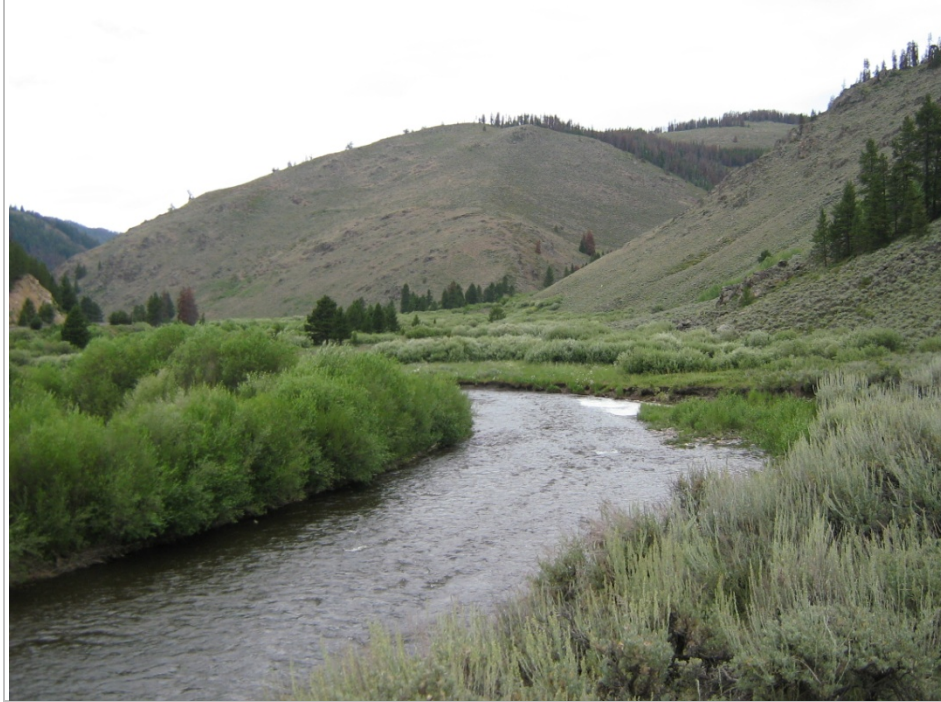
Fraser River Upstream of Canyon

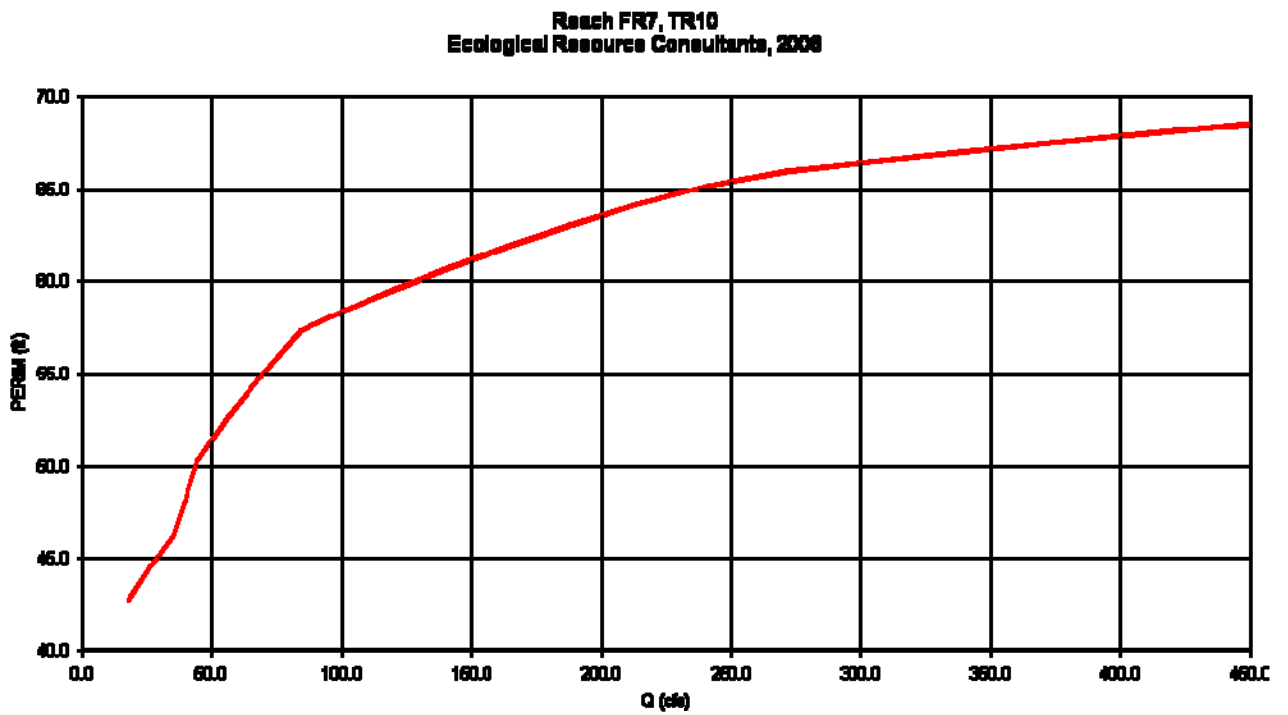
Wetted Perimeter-Flow Relationship

Environmental Flow Methodology: A study site was not established within this reach. Only CWCB instream flow recommendations are available. CWCB flows are evaluated by analyzing wetted perimeter-flow relations from surveyed cross-section data collected by Ecological Resource Consultants (2006) and provided by the U. S. Army Corps of Engineers.

1. CWCB flow recommendations are somewhat low compared to the recommended environmental flow targets. Analysis of the ERC cross-sections indicates that the inflection points for wetted perimeter suggest an instream flow in the 30 to 50 cfs range would be appropriate, a flow range more closely aligned with the environmental flow targets for F6.

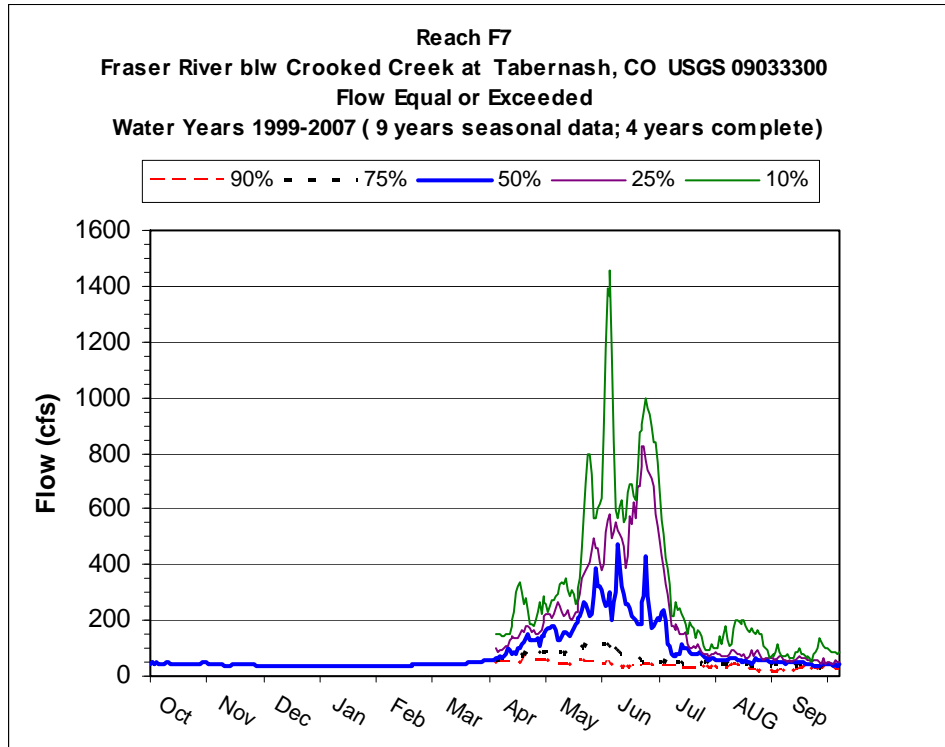
Hydrographs and Exceedence Plots and Tables

Hydrologic Records: USGS Gage Station 09033300 is a seasonal gage located 600 feet downstream of the confluence of Crooked Creek. This gage has been in operation within reach F7 since 1999, with 9 years of seasonal (April 1 - Sept 30) data collected (1999 - 2007) and 4 years of complete data (1999 - 2002). Based upon this short record, the daily streamflow exceedence plots suggest the CWCB flow recommendations are somewhat low compared to the recommended environmental flow targets proposed for Reach F6 just upstream., especially during the April through September period when daily median flows range from over 400 cfs down to about 25 cfs. The 1.25- and 2- year return period high flows are 248 and 592 cfs, respectively, a flow range that surpasses the flushing flow recommendation made for F6.
