## F8 Stream Reach Summary

**Study Reach:** F8, Fraser River - Canyon below Strawberry Road downstream to the River Camp at Granby Ranch Golf Course.

**Reach Description:** Approximate channel length: 5 miles, approximate channel slope 0.8%.

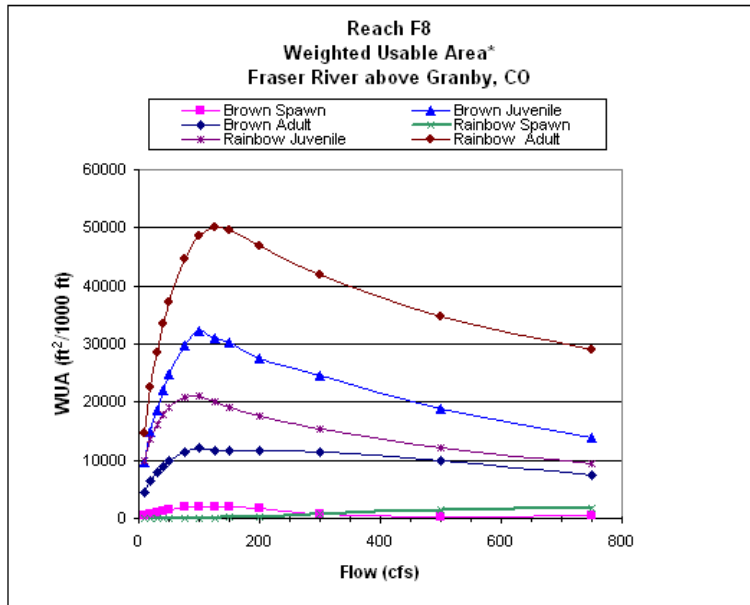
Habitat-flow relations for the target species and life stages for Reach F8 developed by Chadwick and Associates, 1986.

\*Fraser River above Granby (Segment 2, 1978-1985 data collected by Chadwick and Associates)

Reach F8							
Discharge	Total Area	Brown Spawn	Brown Juvenile	Brown Adult	Rainbow Spawn	Rainbow Juvenile	Rainbow Adult
(cfs)	(ft <sup>2</sup> )	Weighted Useable Area (ft <sup>2</sup> /1000 ft stream length)					
10	43550	431	9655	4363	0	9889	14720
20	56740	730	14962	6508	0	13633	22463
30	61335	900	18672	7963	0	16112	28627
40	65048	1191	21967	9042	0	17805	33381
50	68120	1395	24870	9946	0	19133	37246
75	69989	1890	29747	11429	0	20809	44546
100	71145	2016	32114	12179	0	21073	48608
125	72205	2052	31086	11764	115	20019	50073
150	73347	2019	30270	11711	163	19195	49553
200	76507	1754	27415	11593	330	17707	46829
300	79568	674	24550	11469	666	15466	41809
500	82817	339	18846	9837	1464	12121	34774
750	82074	417	13797	7454	1627	9378	29051
