## RE Stream Reach Summary

**Study Reach:** RE, Reeder Creek - From BLM fishing access downstream to the Colorado River.

**Reach Description:** Approximate channel length: 0.5 miles, approximate channel slope 2.5%.

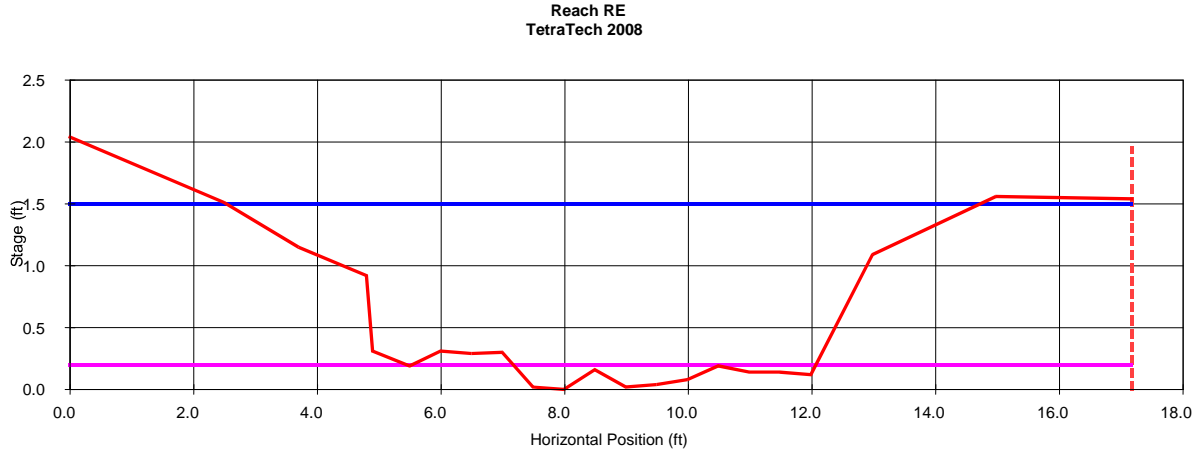
**Transect Hydraulics-Flow Relationships:**

Reach RE										
TT2008 Site										
Resistance Method: Manning's n										
STAGE	AREA	PERIM	WIDTH	R	DHYD	SLOPE	n	VAVG	Q	SHEAR
(ft)	(sqft)	(ft)	(ft)	(ft)	(ft)	(ft/ft)		(ft/s)	(cfs)	(psf)

0.2	0.5	5.1	5.0	0.10	0.10	0.025	0.101	0.5	0.3	0.16
0.3	1.1	7.2	6.9	0.15	0.15	0.026	0.100	0.67	0.7	0.24
0.4	1.8	7.7	7.4	0.23	0.24	0.027	0.099	0.93	1.7	0.39

0.5	2.6	8.0	7.5	0.32	0.34	0.027	0.098	1.17	3.0	0.54
0.6	3.3	8.2	7.6	0.40	0.43	0.028	0.098	1.39	4.6	0.7
0.7	4.1	8.5	7.8	0.48	0.53	0.029	0.097	1.61	6.5	0.87

0.8	4.9	8.7	7.9	0.56	0.62	0.03	0.096	1.81	8.8	1.03
0.9	5.7	9.0	8.0	0.63	0.71	0.03	0.095	2.01	11.3	1.19
1.0	6.5	9.5	8.5	0.68	0.76	0.031	0.094	2.16	14.0	1.32

1.1	7.4	10.2	9.1	0.72	0.81	0.032	0.093	2.29	16.9	1.44
1.2	8.3	11.0	9.9	0.75	0.84	0.033	0.093	2.41	20.0	1.53
1.3	9.3	11.8	10.7	0.79	0.87	0.033	0.092	2.54	23.7	1.65

1.4	10.4	12.6	11.4	0.83	0.91	0.034	0.091	2.68	27.9	1.77
1.5	11.6	13.4	12.2	0.87	0.95	0.035	0.090	2.82	32.7	1.89
