CR6 Stream Reach Summary

Study Reach: CR6, Colorado River - KB Ditch downstream to Blue River Confluence.

GRAND COUNTY
 STREAM MANAGEMENT PLAN
 REACHES

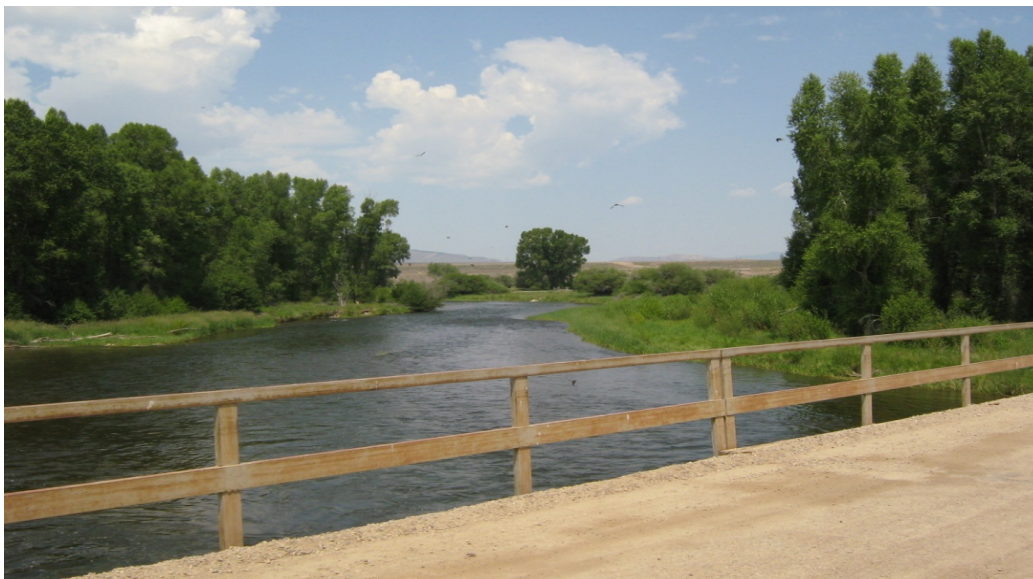
Colorado River immediately downstream of KB

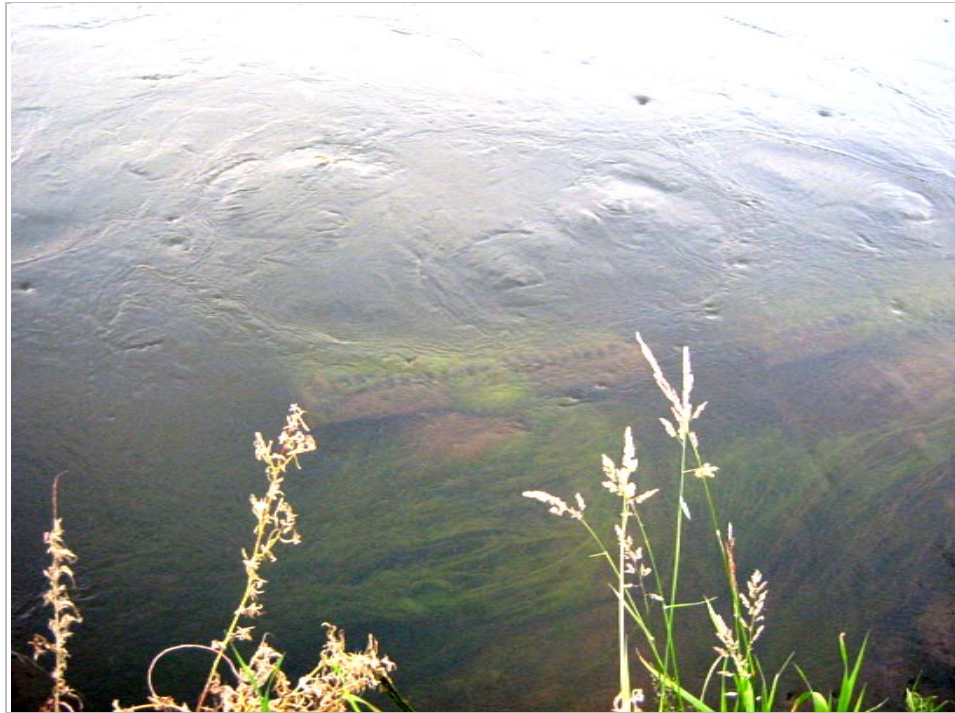
Algae in the River at the Thompson Ranch downstream of Highway 9

- Irrigators, municipalities and industry flow-related issues: Based on discussions with Bill Thompson, this area of the river becomes heavily overgrown with algae during the summer months. The Thompsons run pumps to irrigate and must clean the pump grates sometimes up to three times per day to keep the algae from blocking the grate. During the winter, this area develops large ice layers that causes scour along the bed, sometimes in excess of two feet (Thompson 2007).
- Recreation: Recreation is generally limited to angling.

Water Quality: Algae is a constant nuisance for pumping operations and effects aesthetics. No other water quality concerns were noted from the available data.

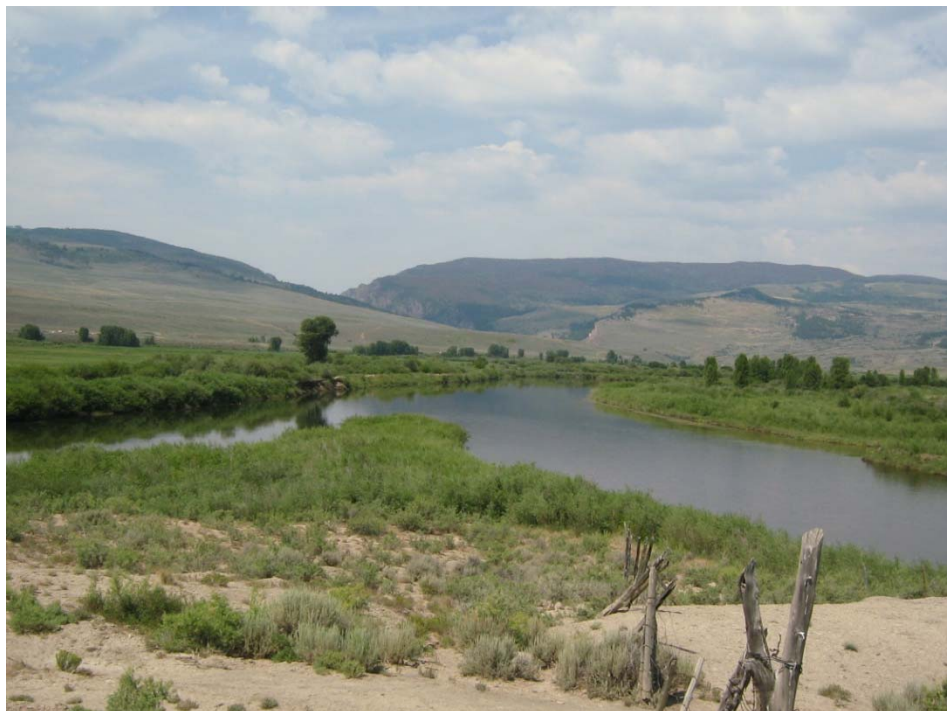
Colorado River at Confluence with Muddy Creek (on right) and Blue River (on left)

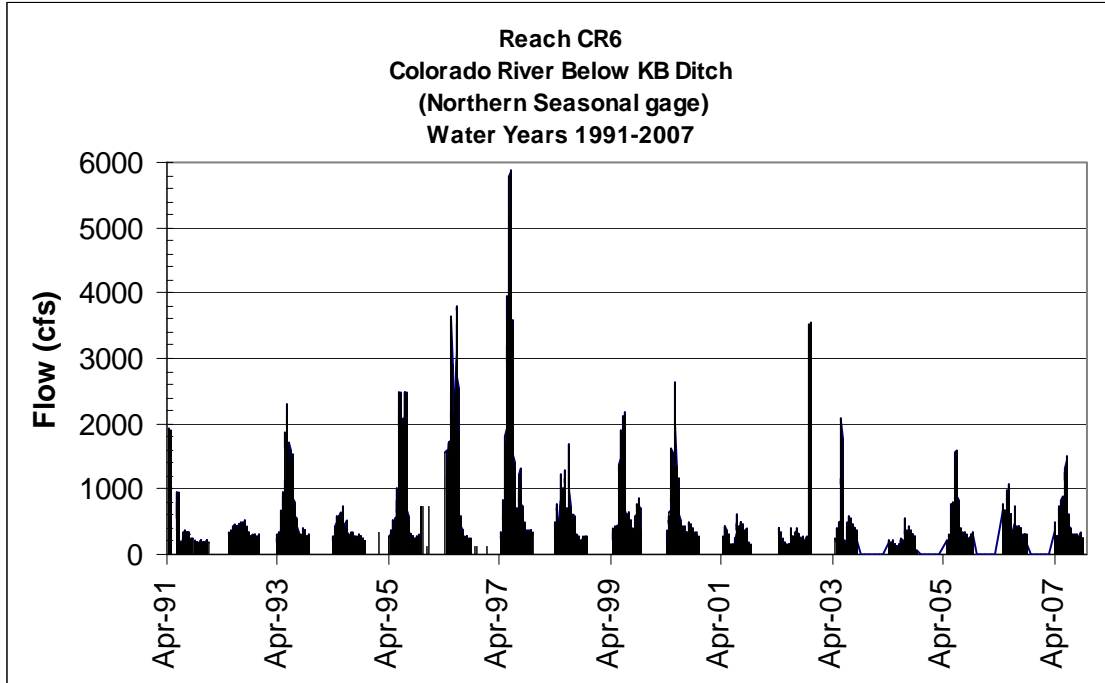
Hydrographs and Exceedence Plots and Tables

Hydrologic Records: The only records available for reach CR6 are seasonal data collected by the Northern Colorado Water Conservation District from 1991 to present at a gage station located just downstream of the KB Ditch. The hydrograph plot and IHA analysis indicate the recommended environmental target flow ranges have been frequently present within the reach over the period-of-record.
