F1 Stream Reach Summary

Study Reach: F1, Fraser River - Lowest switch back on west slope of U.S. Highway 40 downstream to Denver Water Diversion.

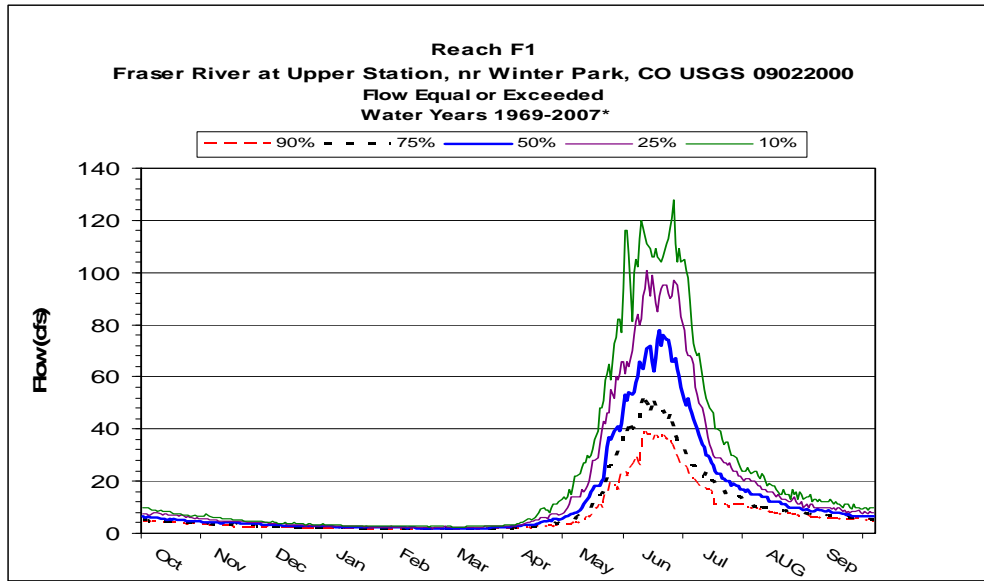
Hydrographs and Exceedence Plots and Tables

Hydrologic Records: USGS Gage Station 09022000 has been operated within this reach from 1969 - 1973 and from 1985 - present. The daily streamflow exceedence plots for this station indicate the recommended CWCB flows are commonly available.

1. Flows recommended by CWCB are commonly available.
2. This reach is above the major transbasin diverters and is relatively unaltered in its flow regime.
3. Water temperatures are likely supportive of a cold-water fishery.
4. Flows for water uses including recreation are generally adequate.
5. This reach is impacted by sand operations along U.S. Highway 40, immediately adjacent to the Fraser River. In addition, erosion observed along the upper switch backs appears to generate sediment that is also transported to the Fraser River.

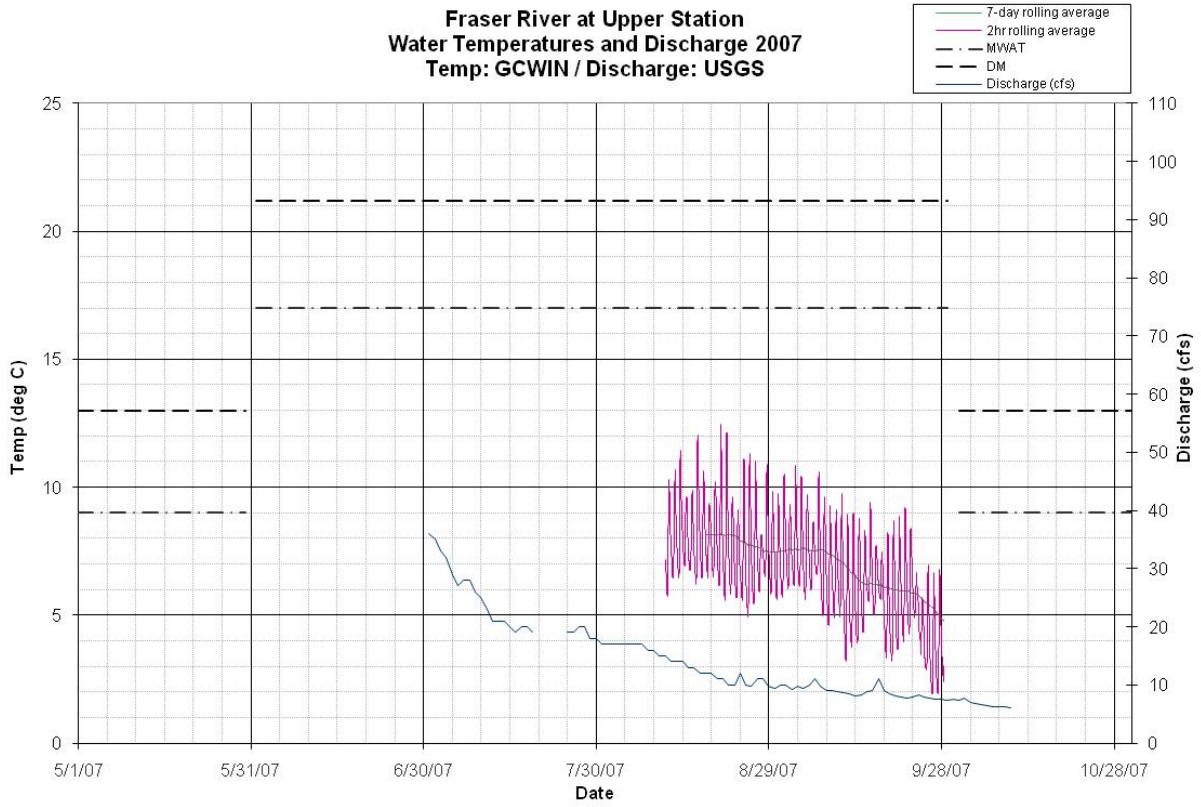
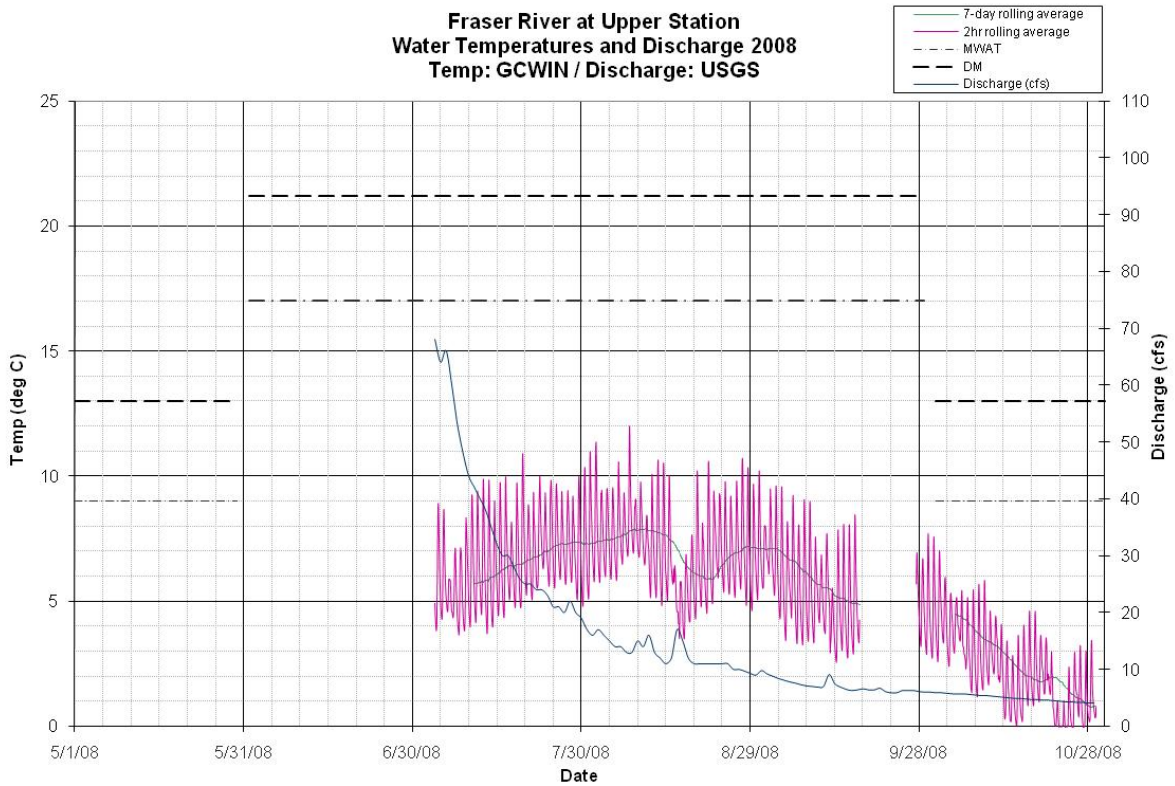
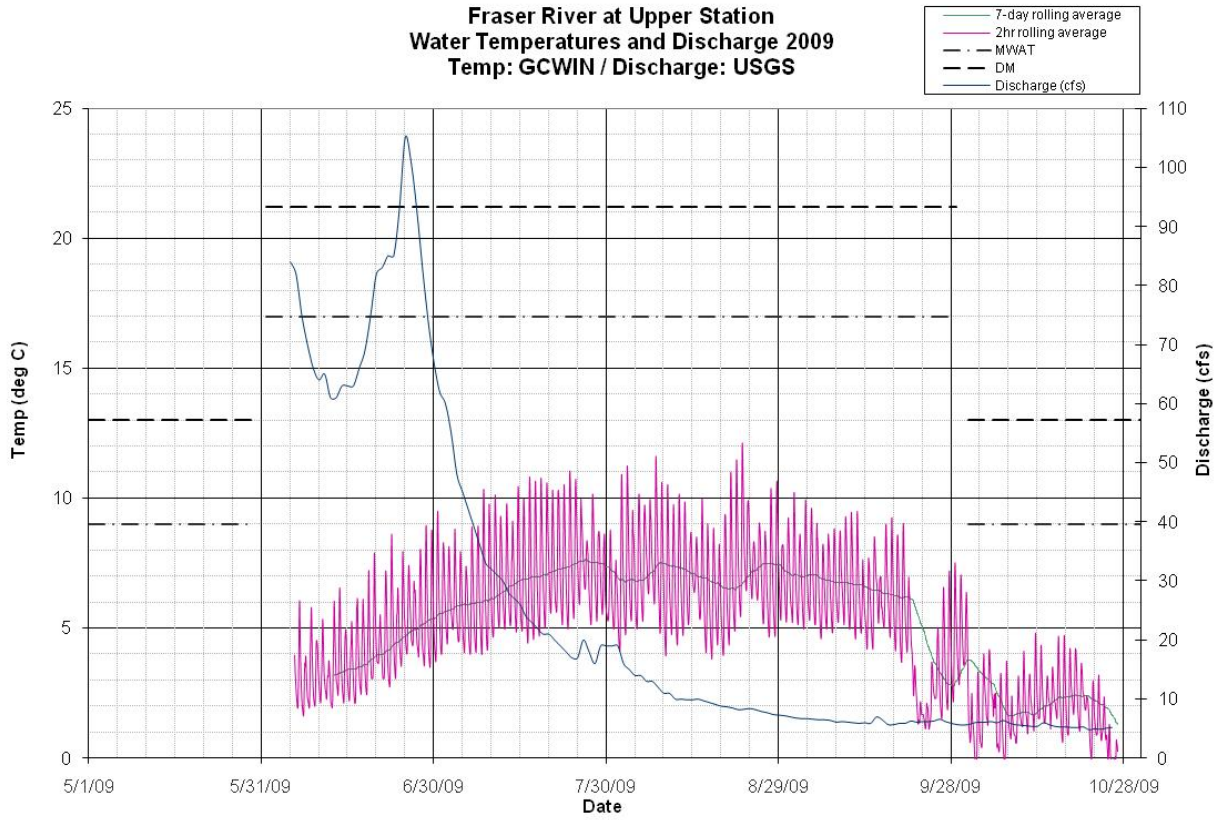
Surface Water Temperature Plots

Water Temperature: F1 is a Tier I stream reach as designated by CDPHE with a chronic temperature standard of 17°C MWAT and an acute temperature standard of 21.2°C DM. Temperature data reviewed in reach F1 indicate stream temperatures for the Fraser River in this area are generally well below the MWAT and DM standards.
