## F4 Stream Reach Summary

**Study Reach:** F4, Fraser River - Town of Winter Park at Idlewild Road downstream to Town of Fraser at Meadow Ridge Road.

**Reach Description:** Approximate channel length: 3 miles, approximate channel slope 1.2%.

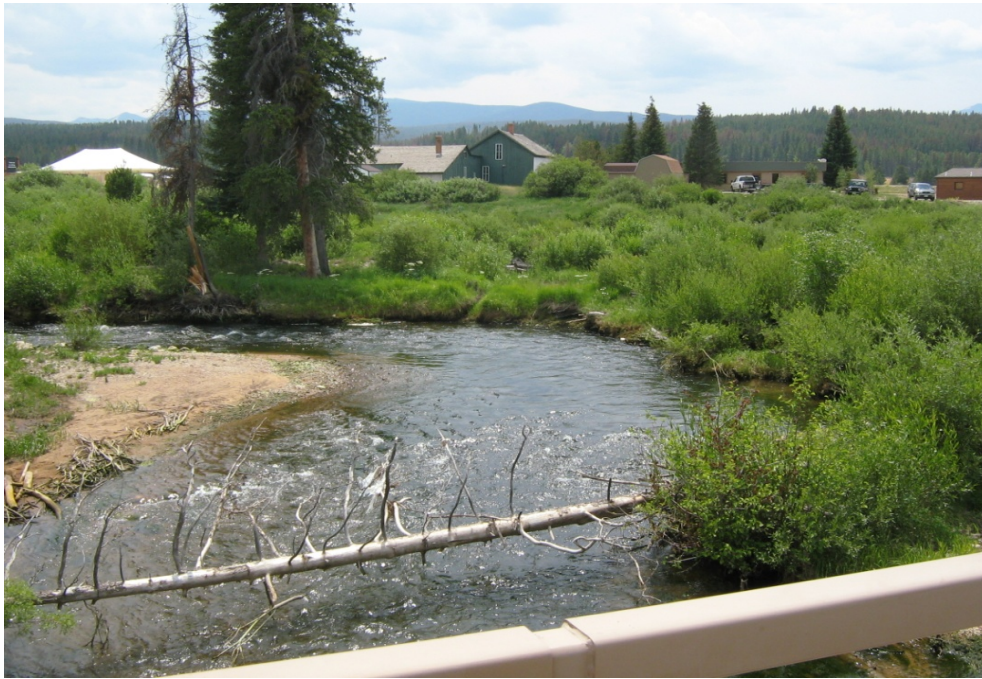
*Fraser River downstream of Winter Park at the Rendezvous Bridge*

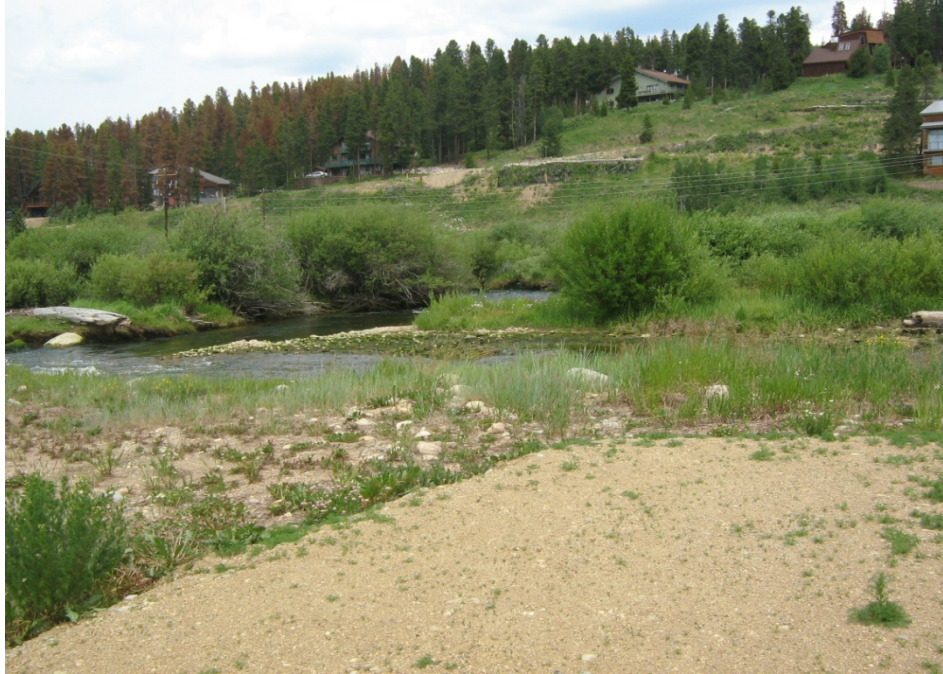
*Fraser River immediately upstream of Fraser near well fields (Note algae on rock bar)*

**Water Quality:** Some algae was observed in summer of 2007, otherwise, there are no indications from existing data that constituents are regularly exceeding criteria. Sanding operations along the highway and side roads could be contributing to the sediment and aggradation observed in the river.

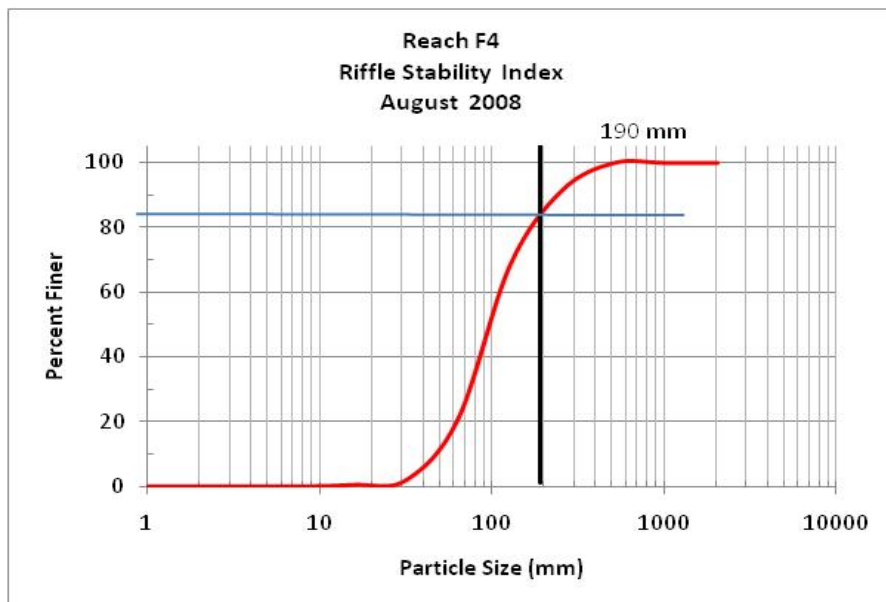
**Stream Assessments:** In August 2008 Tetra Tech conducted three stream assessments in F4. These included Stream Reach Inventory/Channel Stability Evaluation (SRI/CSE), EPA Habitat Quality Assessment (HQA) and a Riffle Stability Index (RSI) evaluation. The SRI/CSE evaluation scored in the ‘good’ category and the EPA HQA evaluation scored in the ‘suboptimal’ range. The RSI of 84 indicates riffle substrate is moderately unstable with up to 84% of particles mobilized by recent high flow events. Overall, the stream assessments did not reveal any issues of significant concern. Results of all three assessments are summarized in the following table and plot. Details and methodology are presented in Appendix A.

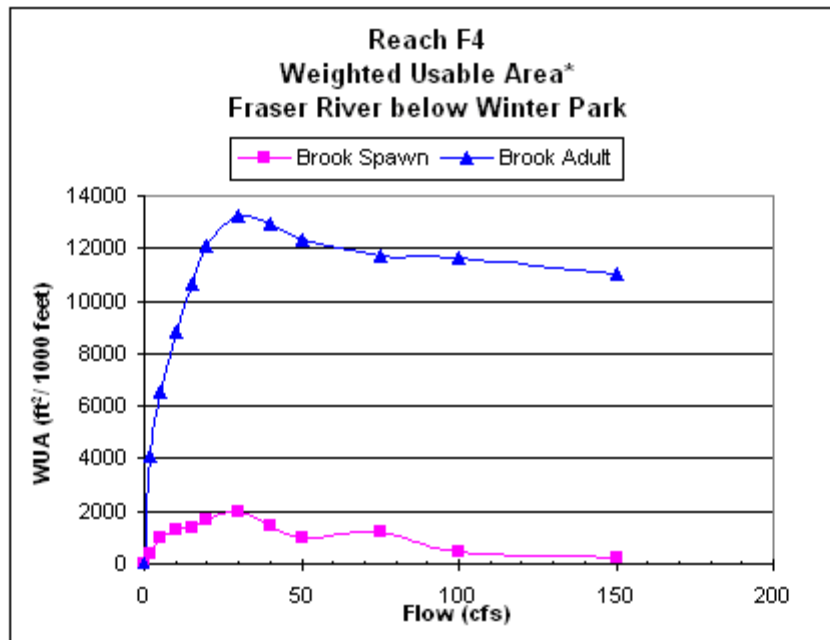
Habitat-flow relations for the target species and life stages for Reach F4 developed by Chadwick and Associates, 1986.

\*Fraser River Segment 1, 1978-1985 data collected by Chadwick and Associates

Reach F4			
Flow	Total Area	Brook Spawn	Brook Adult
(cfs)	(ft <sup>2</sup> )	Weighted Usable Area (ft <sup>2</sup> /1000 ft stream length)	
0	0	0	0
2	15468	392	4121
5	20253	1004	6534
10	24448	1292	8836
15	27198	1395	10683
20	29287	1705	12089
30	31669	2014	13219
40	33531	1443	12904
50	35038	995	12305
75	41242	1184	11696
100	43049	453	11637
150	44428	258	11051
10000	0	0	0

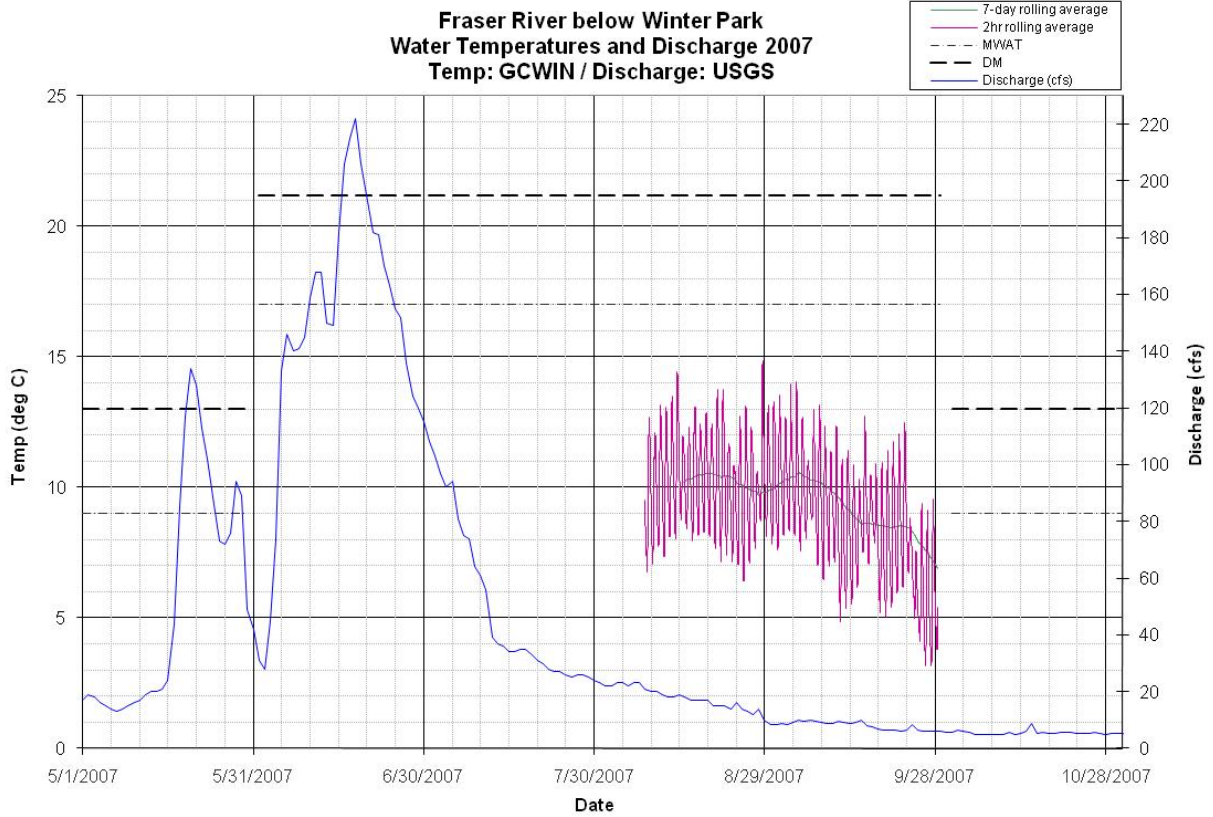
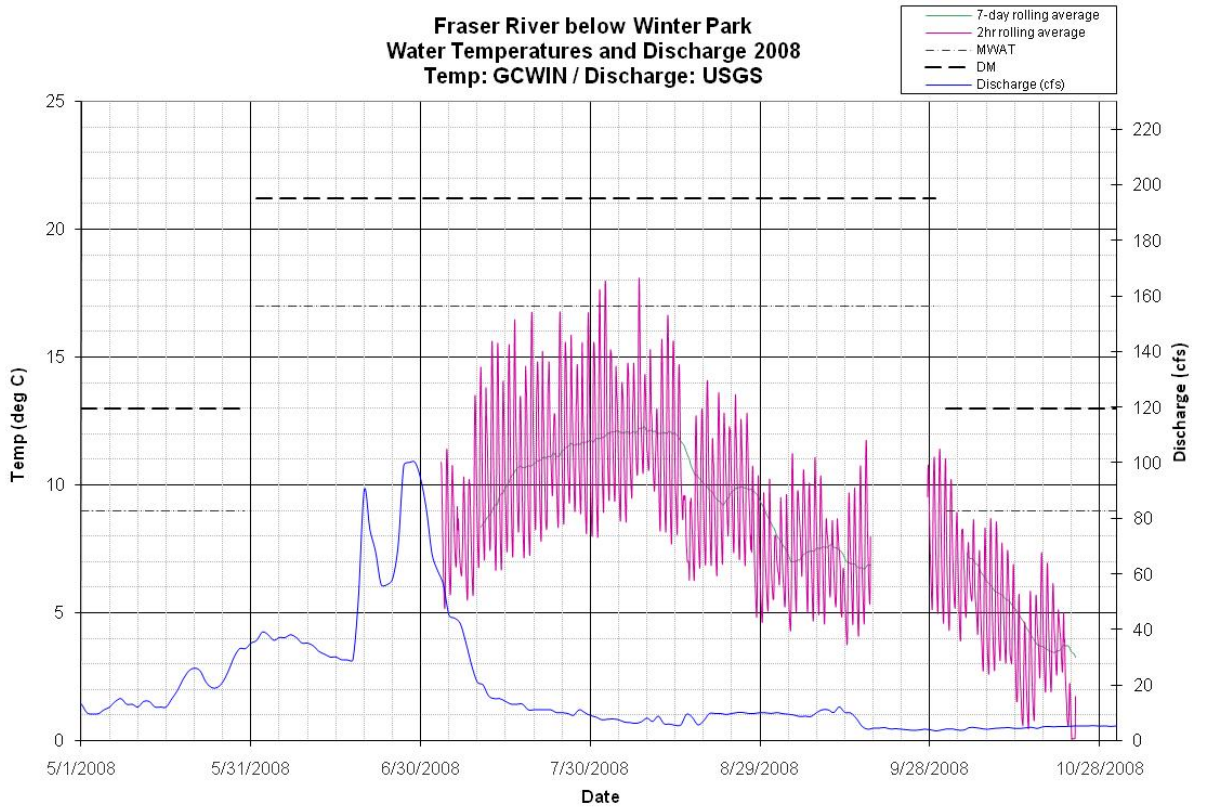
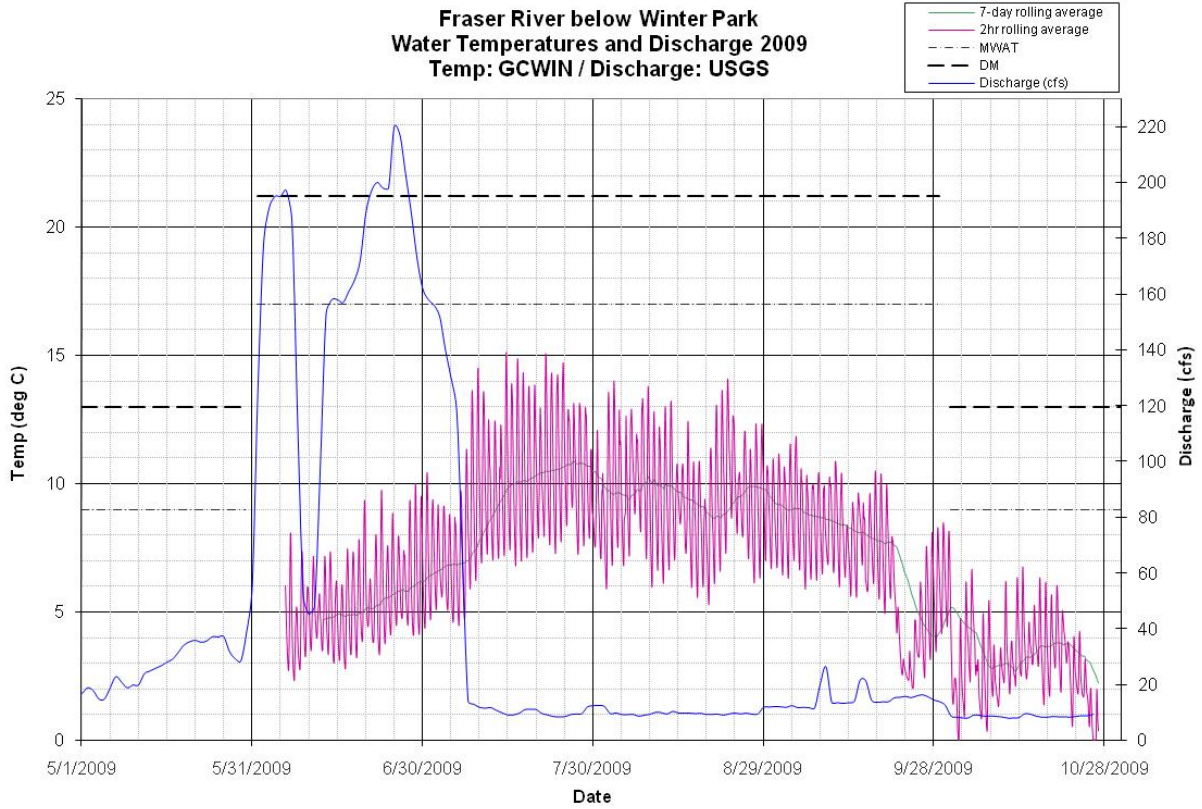
Surface Water Temperature Plots

**Water Temperature:** Two temperature standards exist in reach F4, as defined by CDPHE. Upstream of the Rendezvous Bridge is Tier I; downstream of the Rendezvous Bridge is Tier II. Available temperature data upstream of the Rendezvous Bridge was reviewed and compared to Tier I standards, which includes a chronic standard of 17°C MWAT and an acute temperature standard of 21.2°C DM. Temperature data reviewed in reach F4 indicate stream temperatures for the Fraser River in this area are generally well below the MWAT and DM standards.
