F5 Stream Reach Summary

Study Reach: F5, Fraser River - Town of Fraser at Meadow Ridge Road downstream to the Consolidated Wastewater Treatment facility downstream of County Road 8.

Reach Description: Approximate channel length: 1 ¼ miles, approximate channel slope 1.1%.

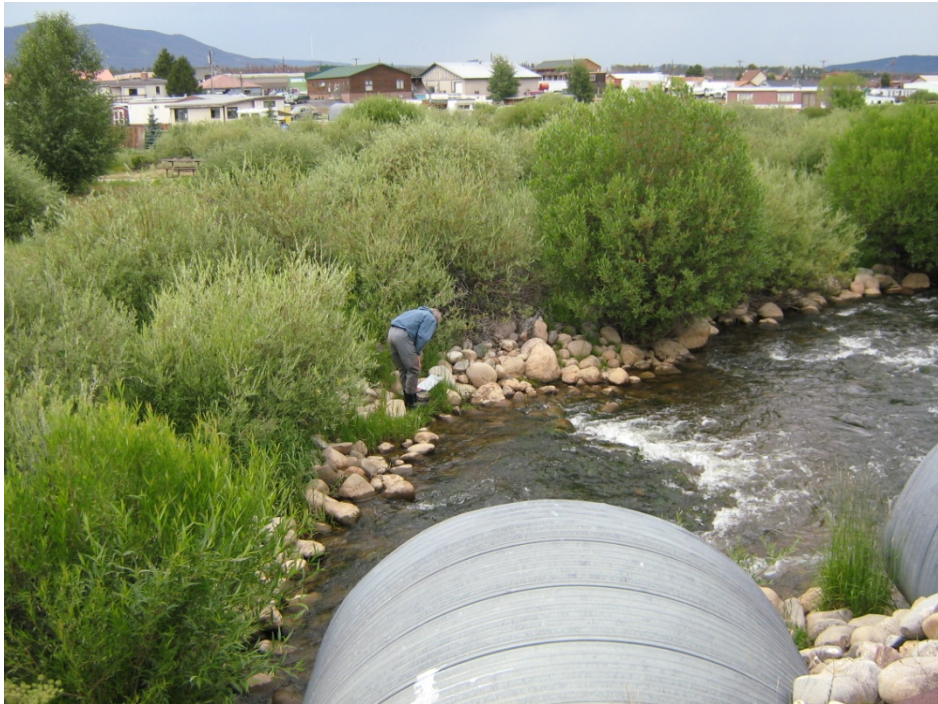
Fraser River Culverts at South Wapiti Drive

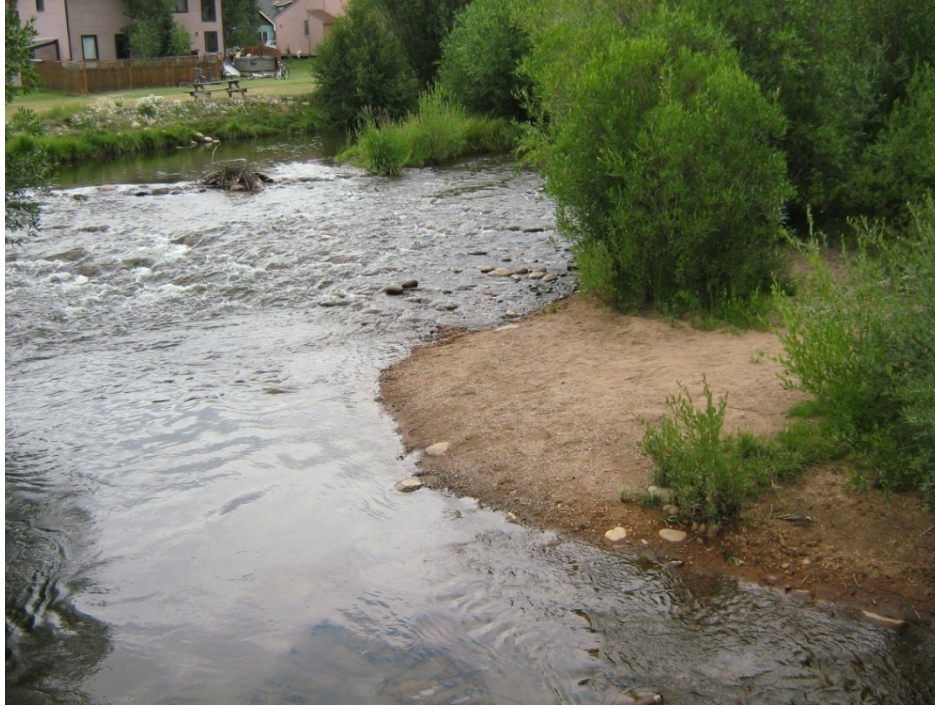
Fraser River in the Town of Fraser

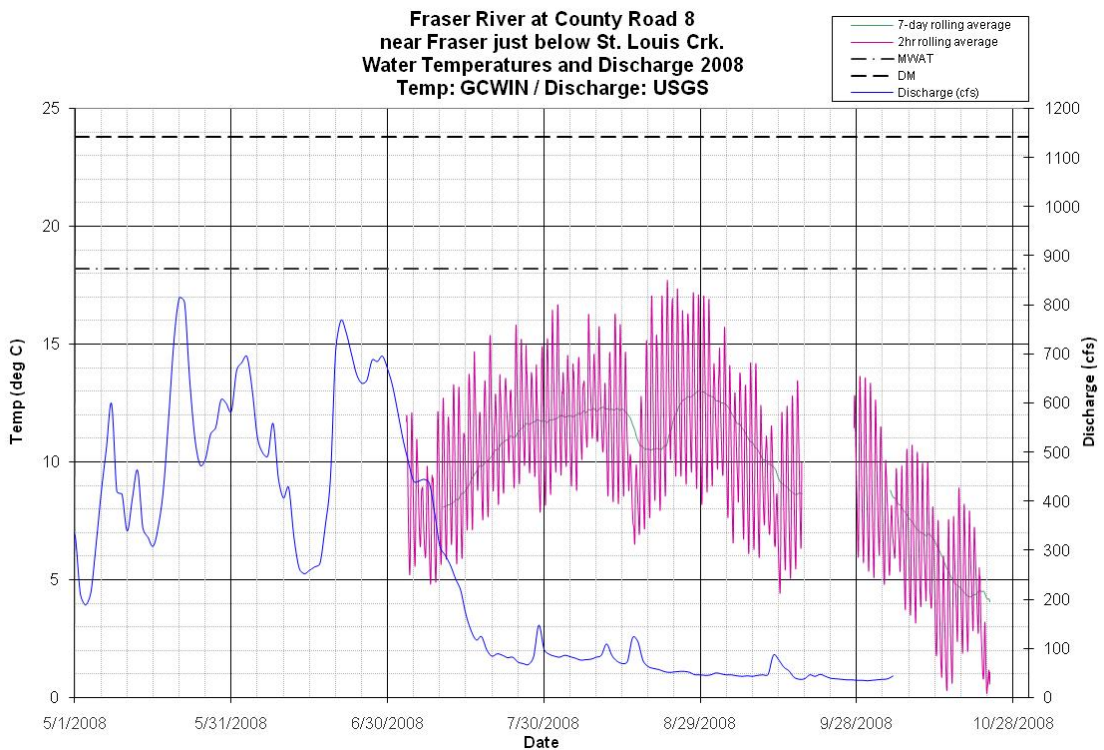
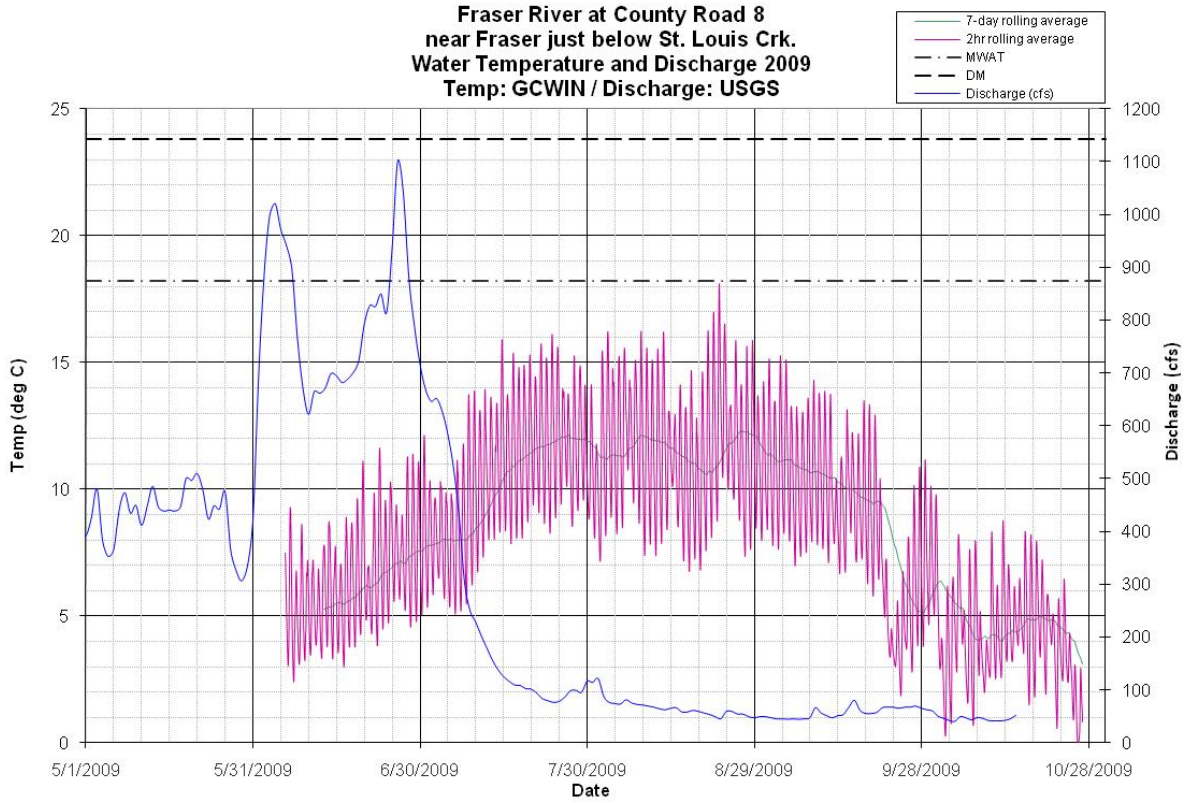
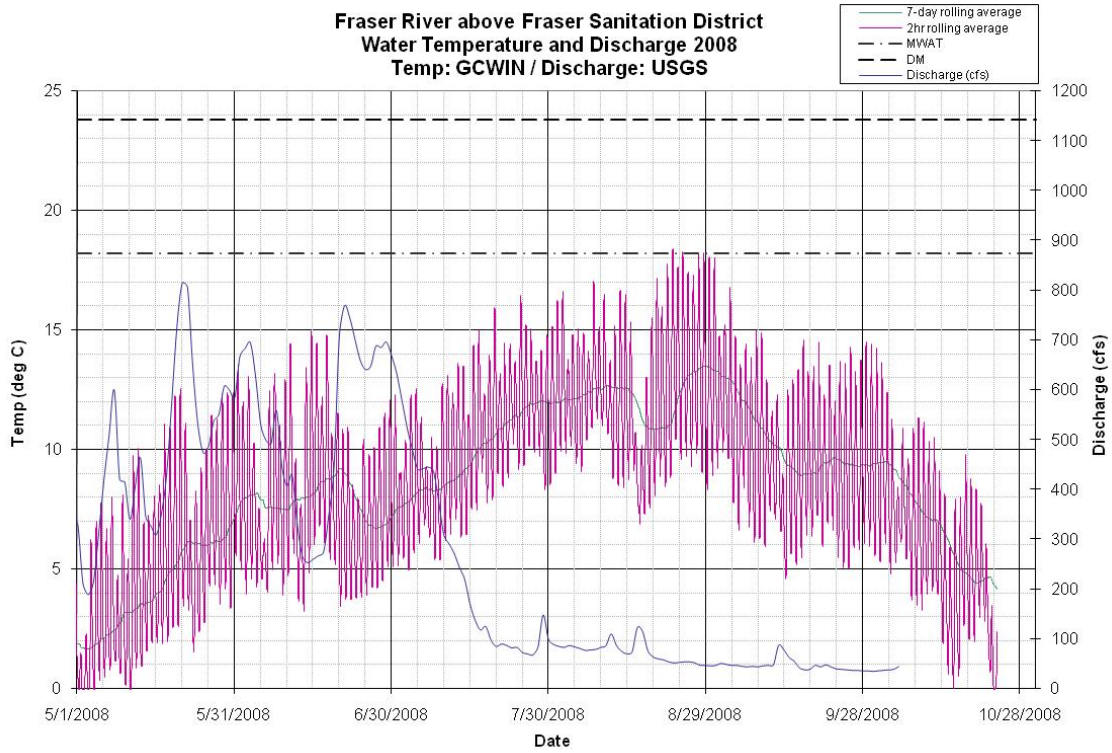
Surface Water Temperature Plots

Water Temperature: F5 is a Tier II stream reach as designated by CDPHE with a chronic temperature standard of 18.2°C MWAT and an acute temperature standard of 23.8°C DM. Temperature data reviewed for reach F5 are generally below standards. However, some exceedences have occurred and resulted in placement of F5 (below Hammond Ditch) on the 303 (d) list of impaired waters for temperature, with a low priority.
