F6 Stream Reach Summary

Study Reach: F6, Fraser River - Consolidated Wastewater Treatment Plant downstream to the confluence with Ranch Creek.

Reach Description: Approximate channel length: 4 ¼ miles, approximate channel slope 0.7%.

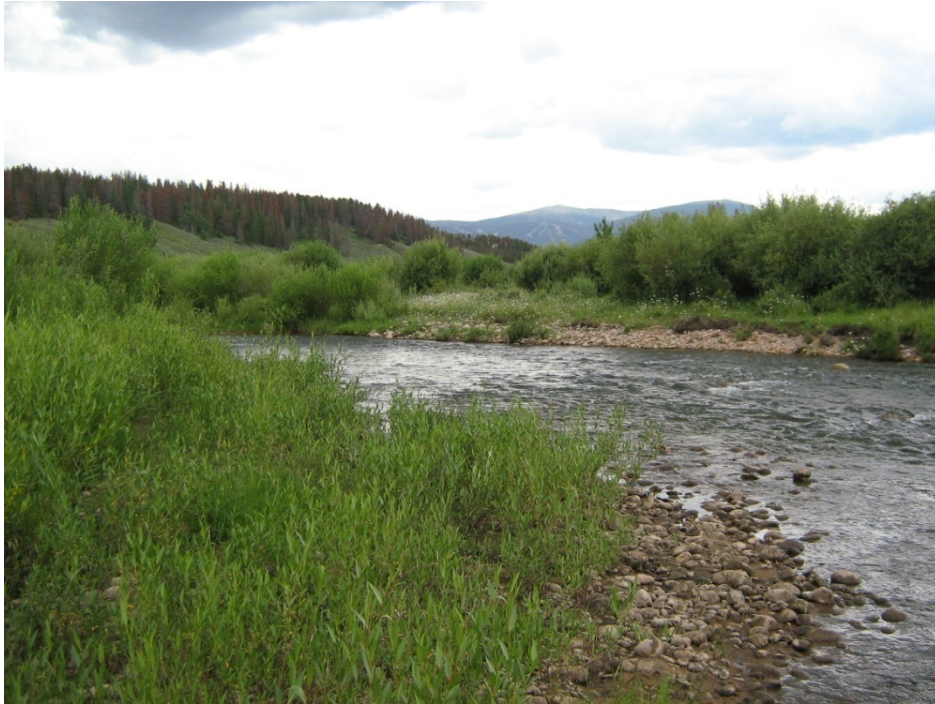
Fraser River Downstream of the Consolidated Treatment Plant

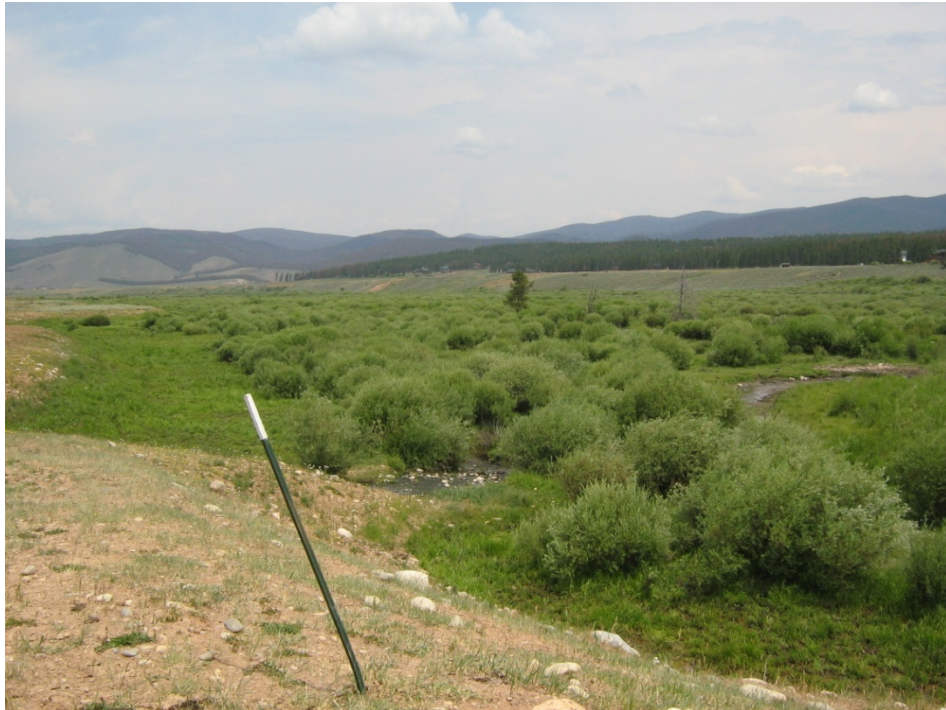
Fraser River downstream of WWTP

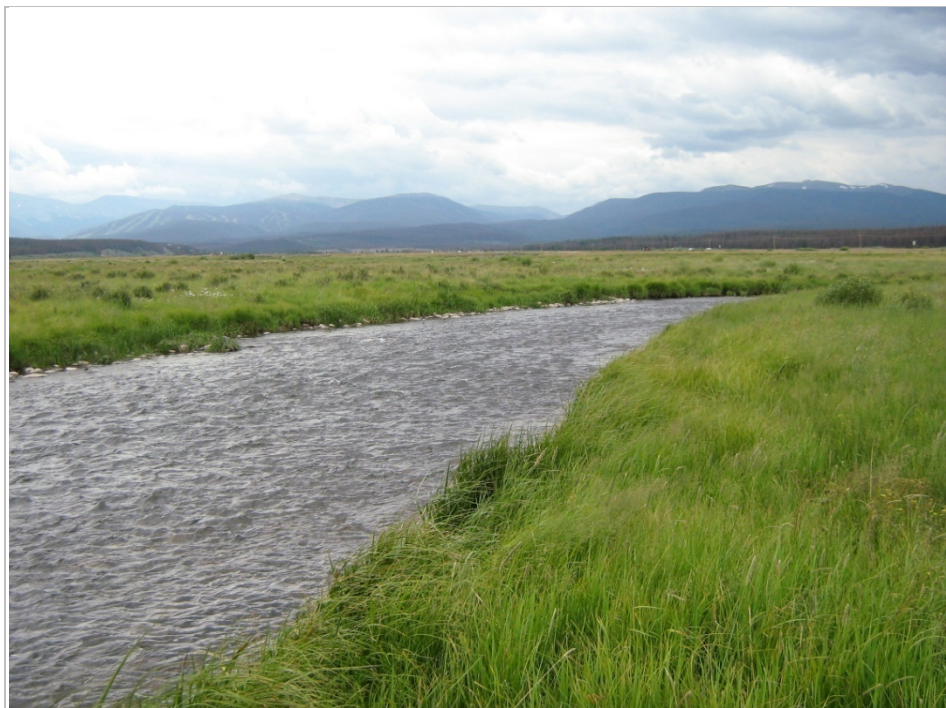
Downstream Portion of F6 near County Road 83. Note wide, shallow channel

6. Some habitat restoration efforts have been observed on the downstream portion of F6 near County Road 83. As of May 2010 the details of this restoration are unknown.

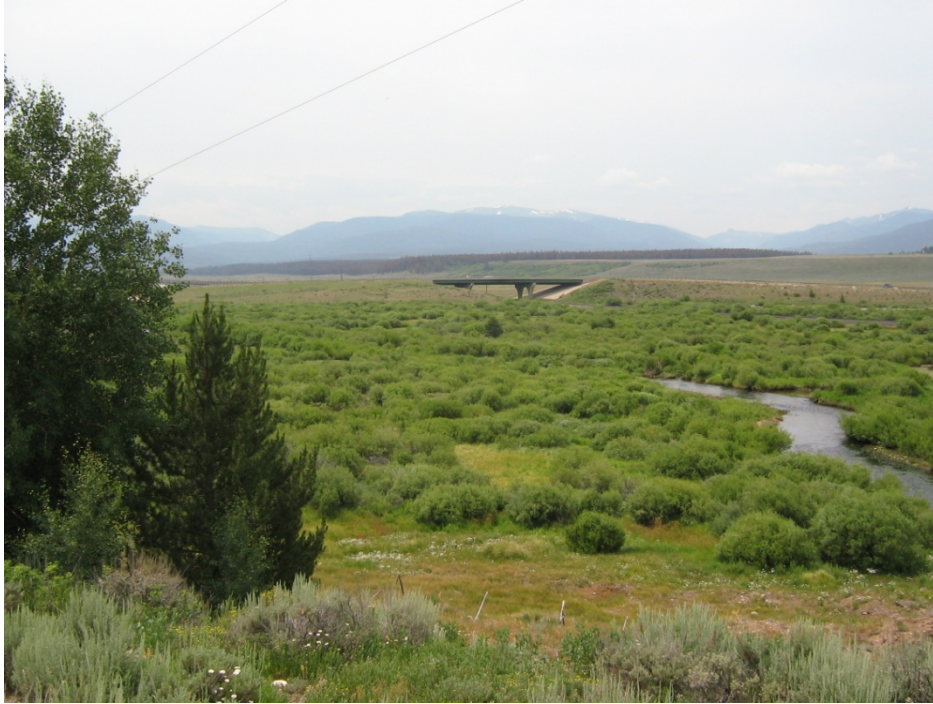
Fraser River at Ranch Creek Confluence. Note lack of vegetative overstory and shading

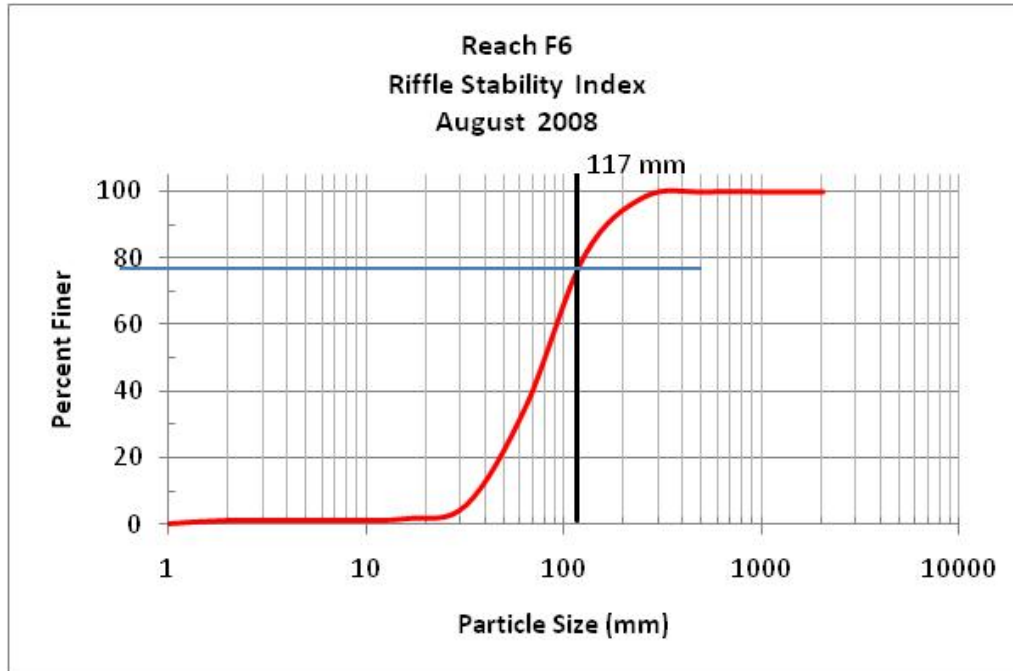
Stream Assessments: In August 2008 Tetra Tech conducted three stream assessments in F6. These included Stream Reach Inventory/Channel Stability Evaluation (SRI/CSE), EPA Habitat Quality Assessment (HQA) and a Riffle Stability Index (RSI) evaluation. The SRI/CSE evaluation scored in the 'good' category and the EPA HQA evaluation scored in the 'suboptimal' range. The RSI of 76 indicates riffle substrate is moderately unstable with up to 76 % of the particles mobilized during recent high flow events. Relevant issues revealed in the stream assessments include some bank degradation from grazing and lack of shading. Results of all three assessments are summarized in the following table and plot. Details and methodology are presented in Appendix A.

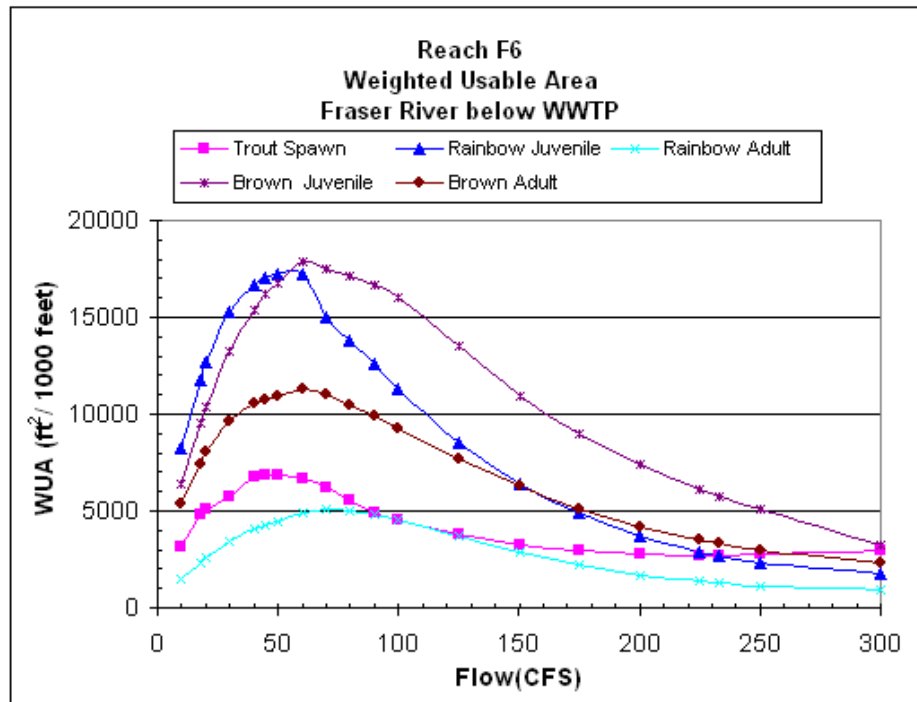
Habitat-flow relations for the target species and life stages for Reach F6, Tetra Tech site.

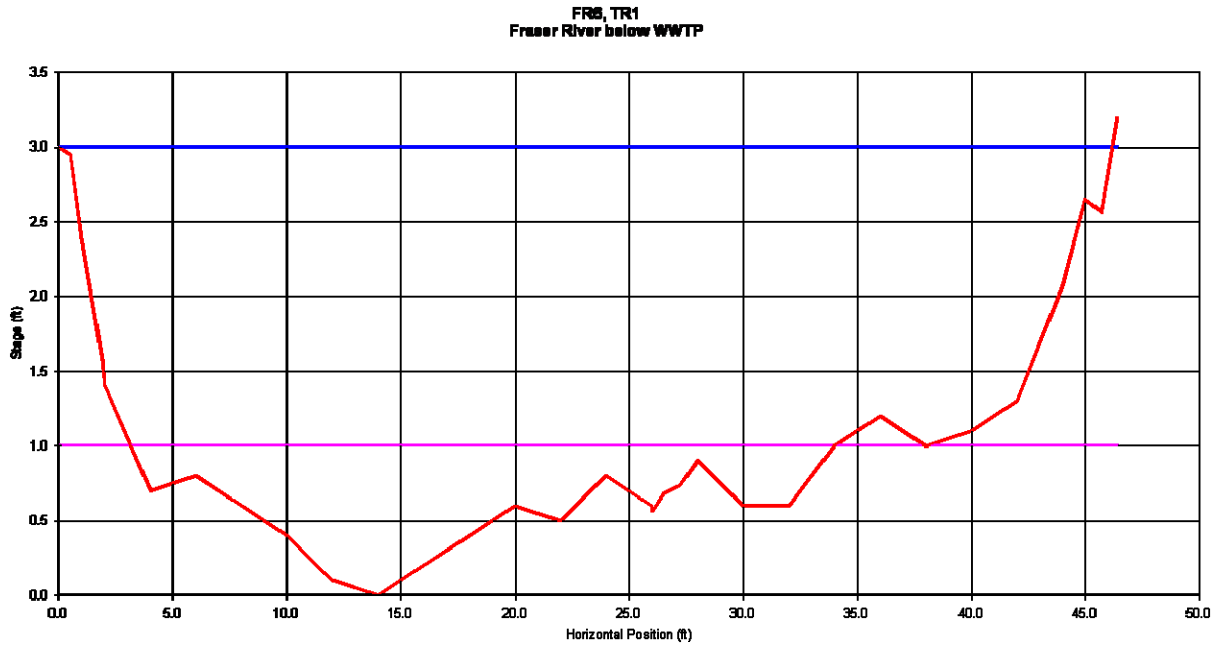
FR6, TR1
TT2007 site

Transect and Bedload Threshold Plots and Tables

Resistance Method: Jarrett's Equation

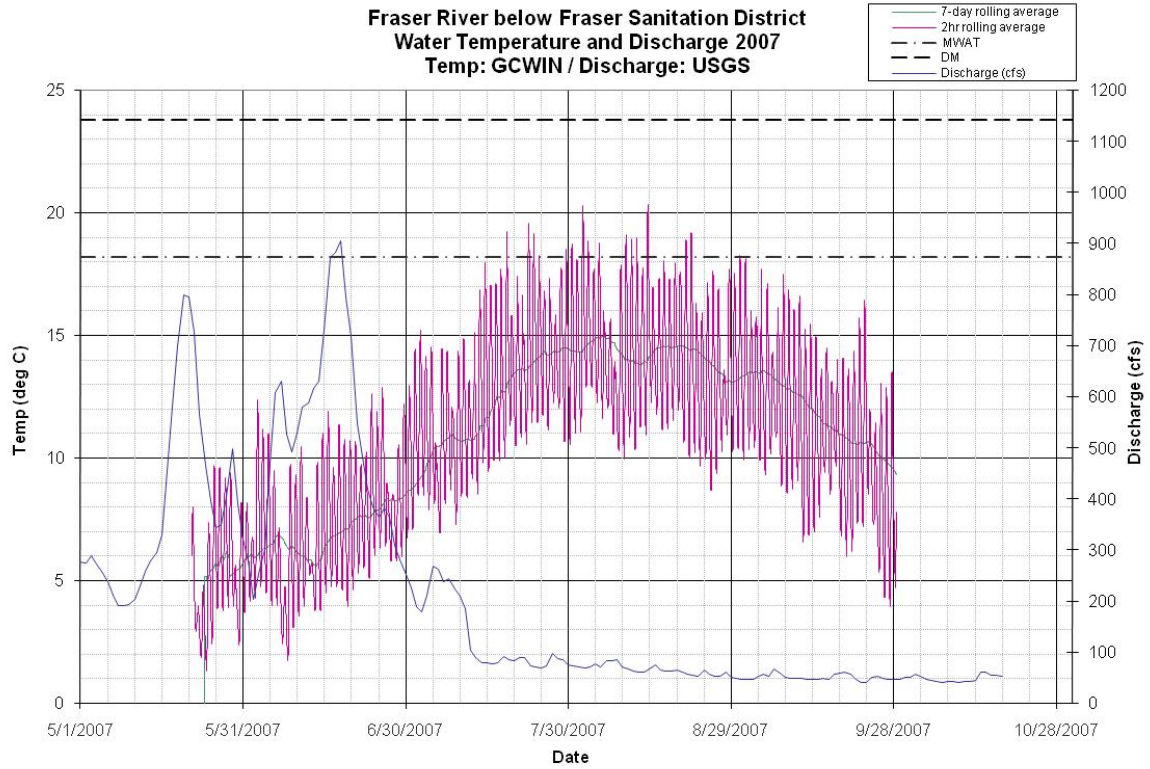
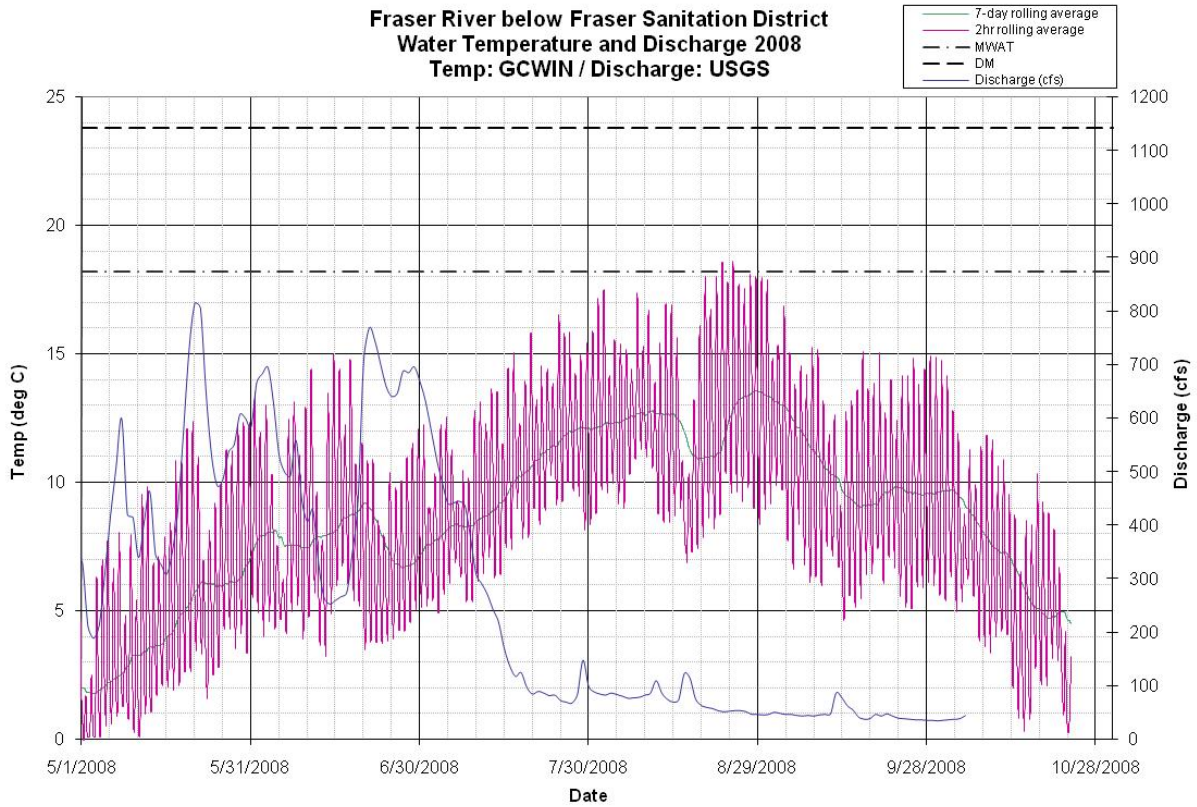
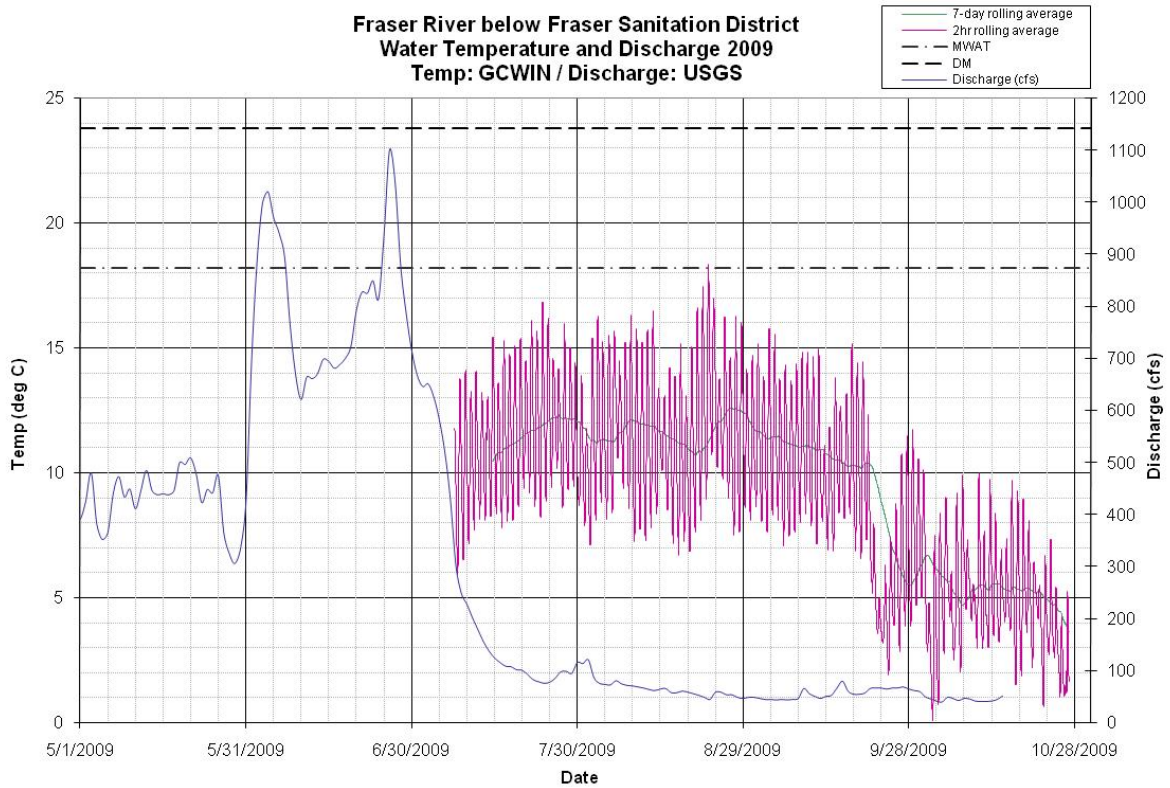
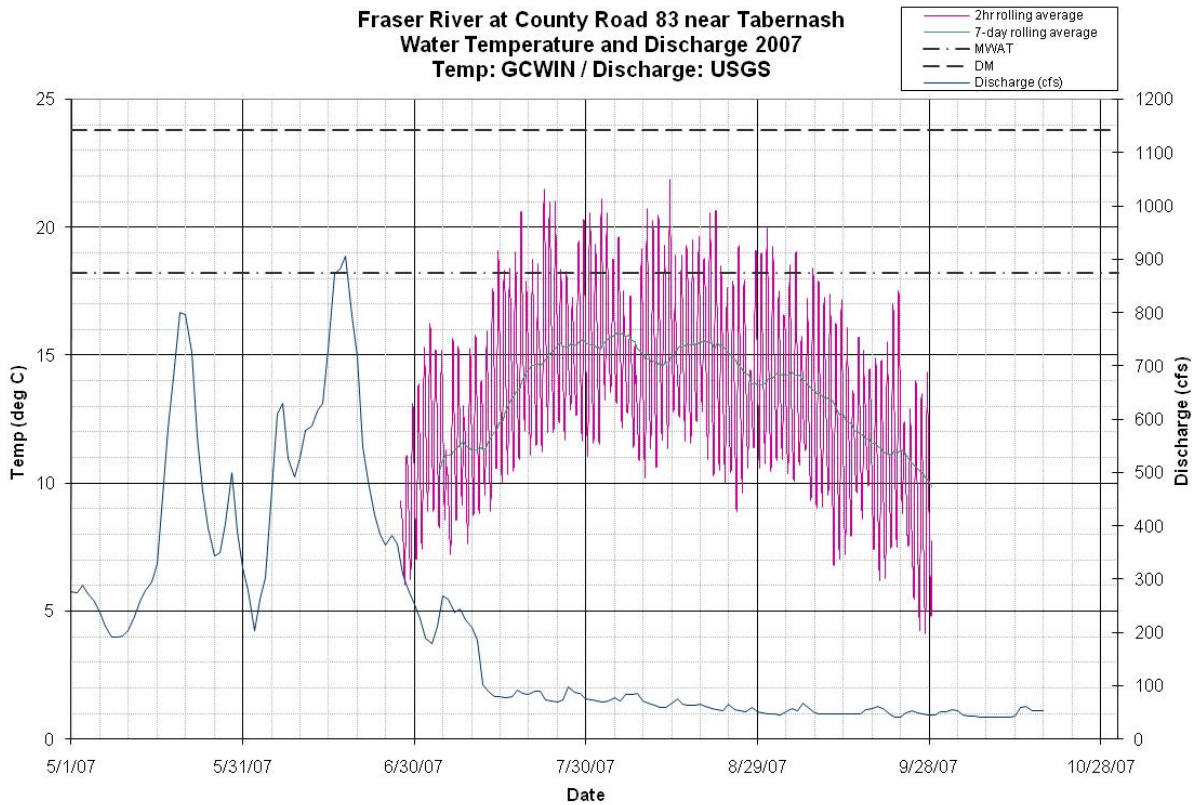
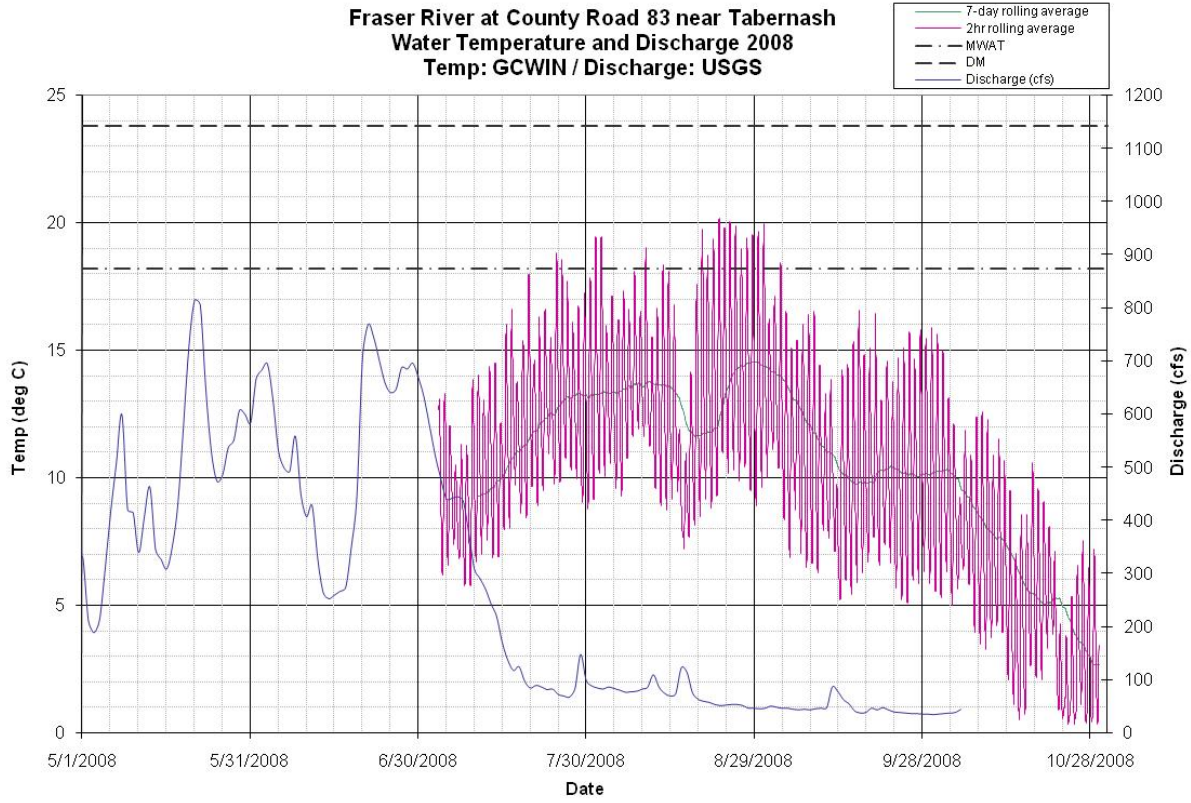
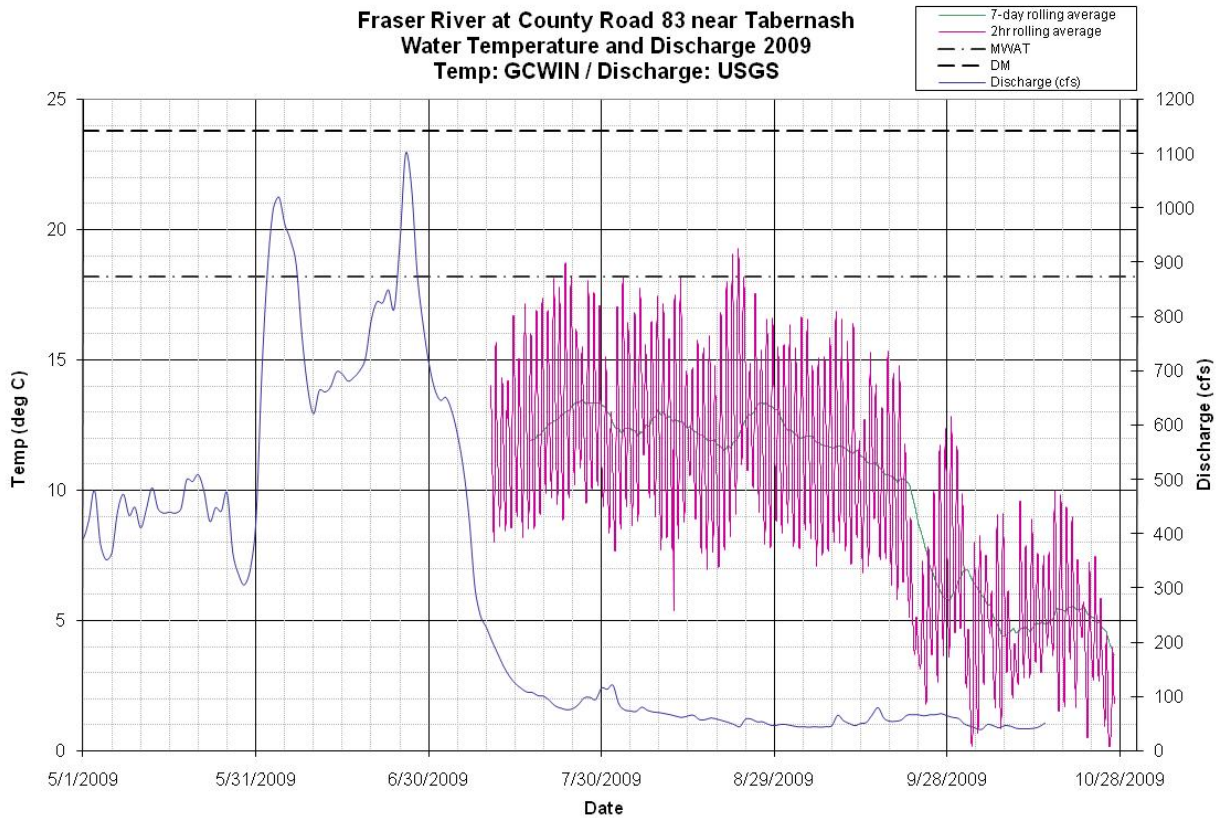
Surface Water Temperature Plots

Water Temperature: F6 is a Tier II stream reach as designated by CDPHE with a chronic temperature standard of 18.2°C MWAT and an acute temperature standard of 23.8°C DM. Temperature data reviewed for reach F6 are generally below standards. However, some exceedences have occurred and resulted in placement of F6 on the 303 (d) list of impaired waters for temperature, with a low priority.
