## F8 Stream Reach Summary

**Study Reach:** F8, Fraser River - Canyon below Strawberry Road downstream to the River Camp at Granby Ranch Golf Course.

**Reach Description:** Approximate channel length: 5 miles, approximate channel slope 0.8%.

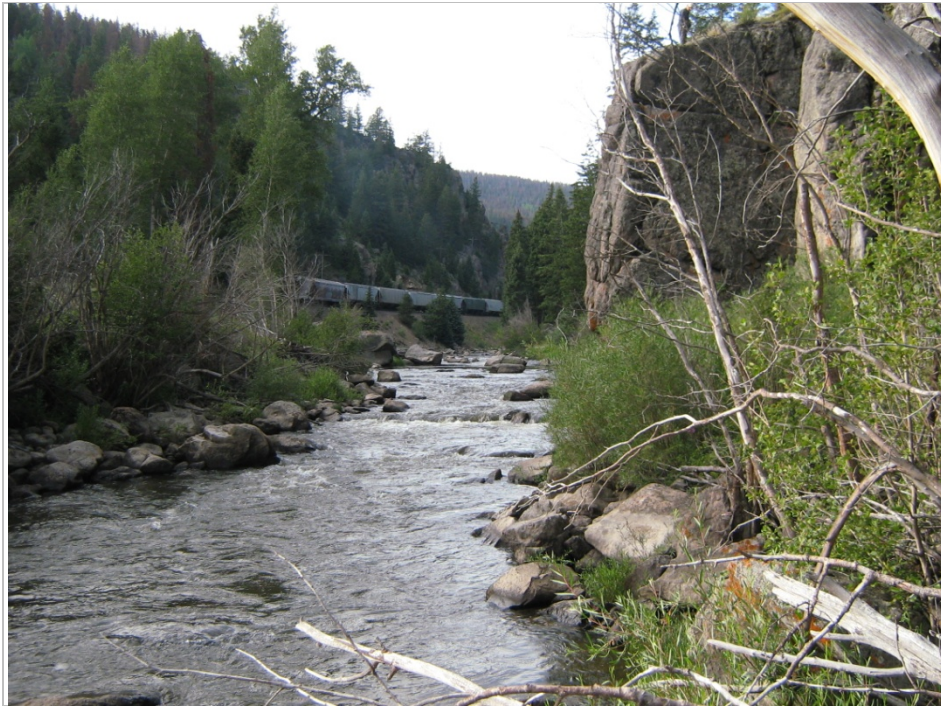
*Fraser River Canyon*

This section of the Fraser River is remote and scenic. The public cannot easily access this area due to the canyon confines on the upstream end and the private land ownership on the downstream end. The reach begins as a narrow, confined and relatively steep canyon. The railroad follows the river through the canyon and often encroaches on the floodplain corridor. On the downstream end of the canyon, the valley opens to meadows, flatter slopes and an unconfined floodplain.

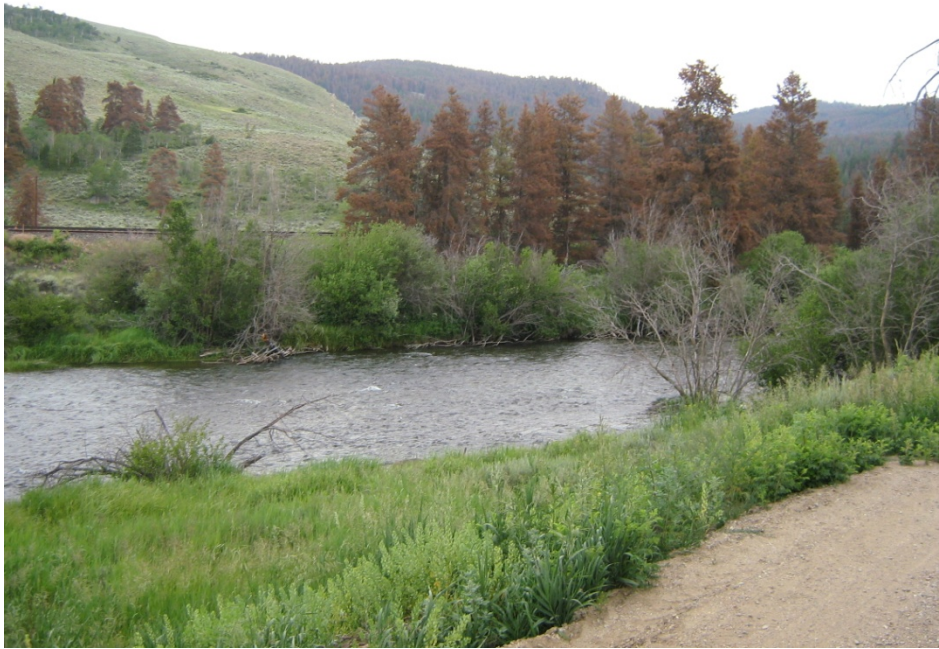
*Fraser River at 'River Camp' located downstream of canyon at the Granby Ranch Golf Course*
