F1 Stream Reach Summary

Study Reach: F1, Fraser River - Lowest switch back on west slope of U.S. Highway 40 downstream to Denver Water Diversion.

GRAND COUNTY
STREAM MANAGEMENT PLAN
REACHES

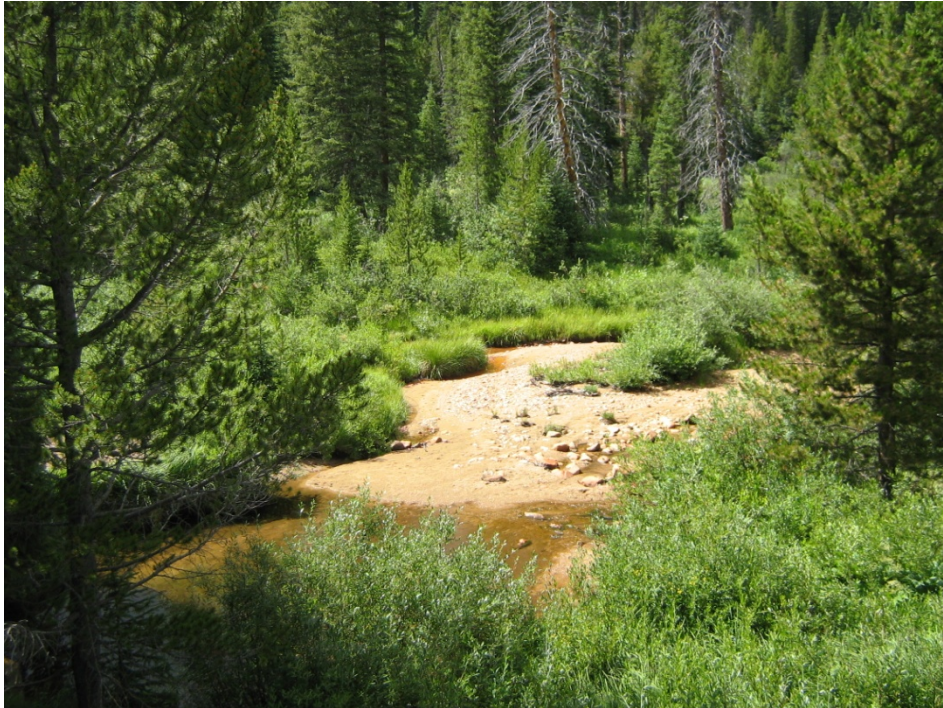
Fraser River upstream of the Denver Water diversion intake

This is the most upstream reach of the Fraser River within the study footprint. The upstream limits begin at the first or lowest west slope switch back where the Fraser and U.S. Highway 40 converge and extends to the Denver Water Fraser River Diversion intake. This reach is relatively steep with vegetated overbanks, varying between wetlands-type vegetation and pine forests. The channel bed is predominantly cobble, with some areas heavily embedded with finer sediments as shown in the photograph below. One source of the fine sediment is likely from winter sanding operations along U.S. Highway 40. Erosion along the cut slopes of the highway, particularly along the switch backs in the upper basin, are also evident and likely to contribute to the sediment loading along F1. A sediment removal project at the Denver Water Fraser River Diversion intake is proposed and currently being implemented in a joint effort by the County, Denver Water, CDOT and the USFS (see F2).

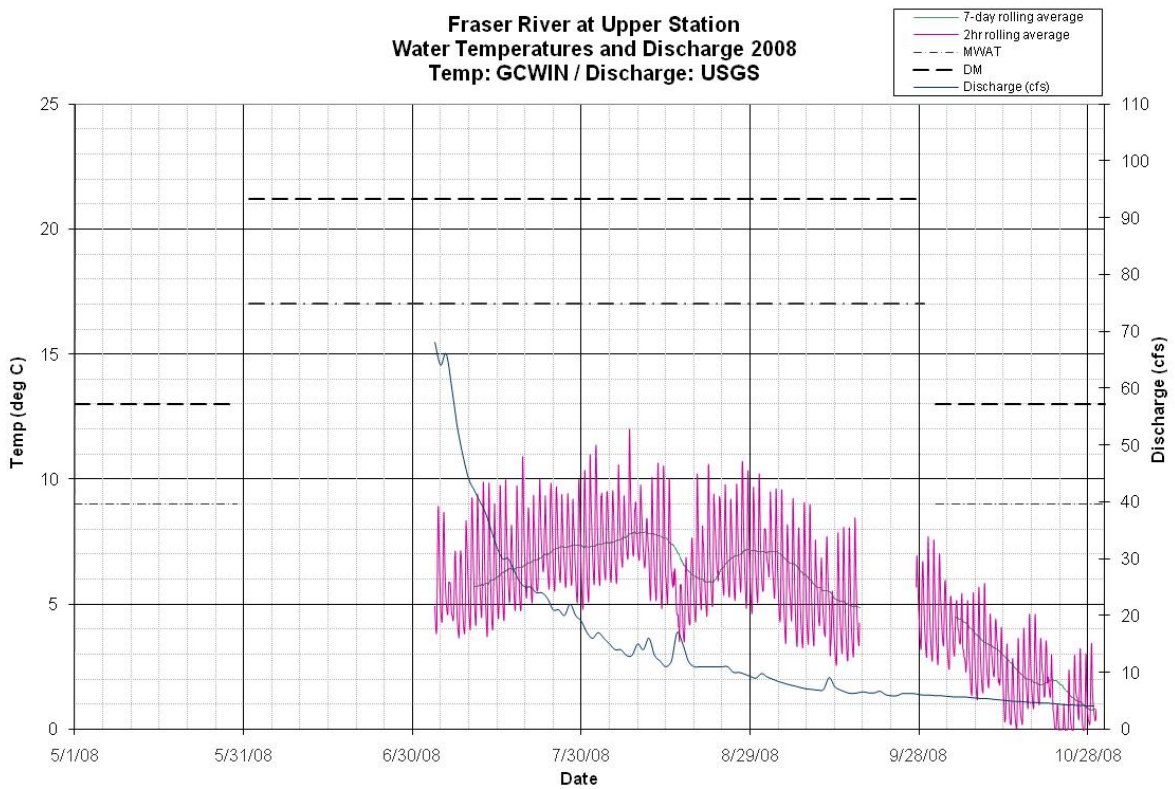
Surface Water Temperature Plots

Water Temperature: F1 is a Tier I stream reach as designated by CDPHE with a chronic temperature standard of 17°C MWAT and an acute temperature standard of 21.2°C DM. Temperature data reviewed in reach F1 indicate stream temperatures for the Fraser River in this area are generally well below the MWAT and DM standards.
